Wind Turbine Blade Failures

Subjects: Engineering, Mechanical

Contributor: Dimitris Katsaprakakis

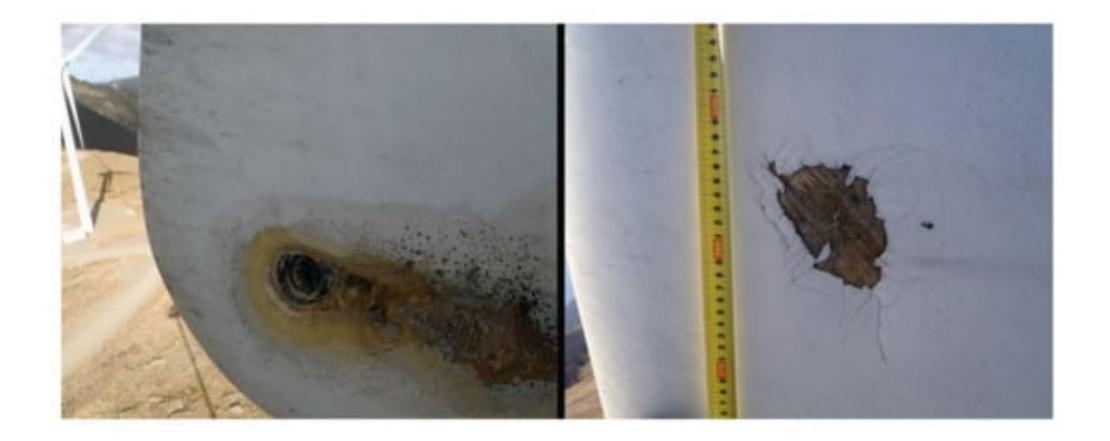
Delamination: Delamination is normally caused by the localised build-up of pressure and abrupt expansion of the lightning arc column, combined with the structural degradation of the resin (due to incineration or overheating) between the laminate plies due to the temperature of the lightning channel. This causes the plies of the laminate to detach from each other (**Figure 1**). Usually, lightning-induced delamination is accompanied by punctures and burns on the laminate near the point of impact. Although delamination mainly occurs close to the blade tip, it can be found at any position between the blade tip and the hub.

Figure 1. Delamination and burn at the conductor's edge point on the wind turbine's blade. Typical wear due to lightning strike.

The main problem with delamination is that it creates favourable conditions for the onset and development of cracks. This is especially troublesome in wind turbine blades, because of the fatigue loading that the structure is subjected to.

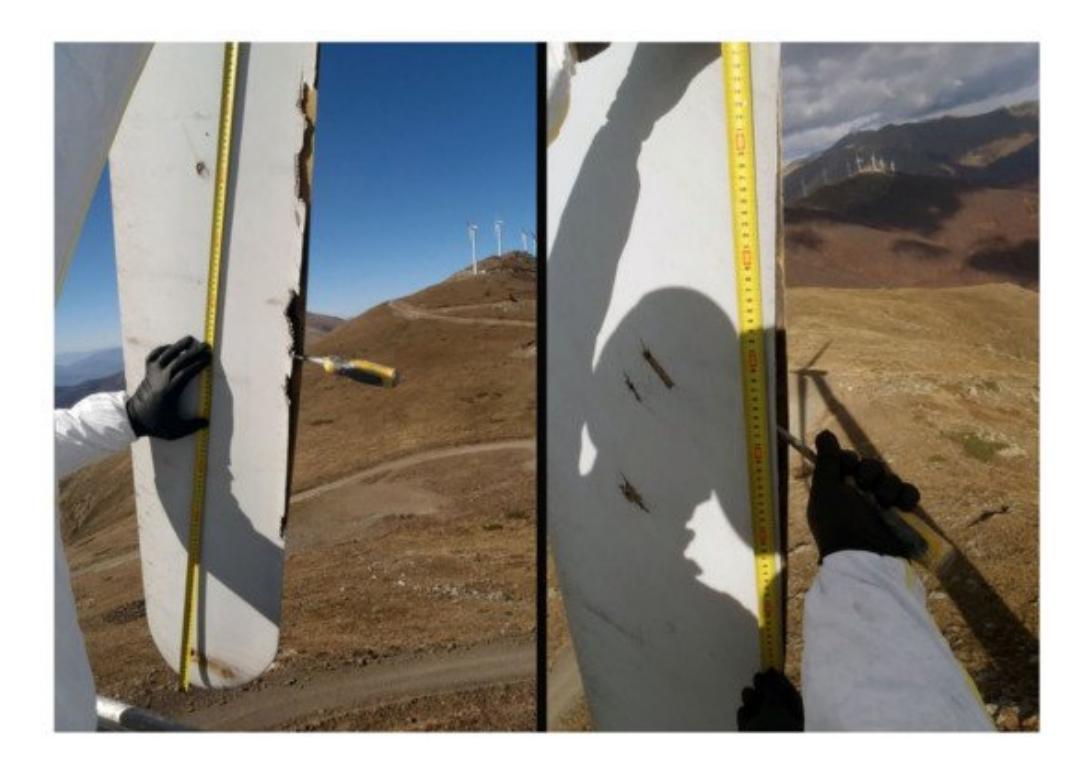
Debonding: Debonding consists of a localized separation of the upper and lower shells of the blade. It is usually present at the tip or at the trailing edge in the outer few meters of the blade (**Figure 2**). Usually debonding is caused because the heat generated from the lightning expands the air inside the blade, thus creating internal pressure. The vaporisation of condensed moisture trapped inside the blade can intensify this phenomenon. Debonding is mainly located very close to the tip of the blade, in distances lower than 1 m. However, there can be cases of shell debonding traced in distances up to 6 m from the tip. This is attributed to the fact that the blade is more robust near the hub, and therefore the expansion of air is not usually sufficient to cause the separation of the shells. Additionally, the blade tips are more likely to attract lightning.

Figure 2. Shell debonding of around 1 m length, starting at 40 cm from the blade's tip (**left photo**) and extending 60 cm in length (**right photo**).

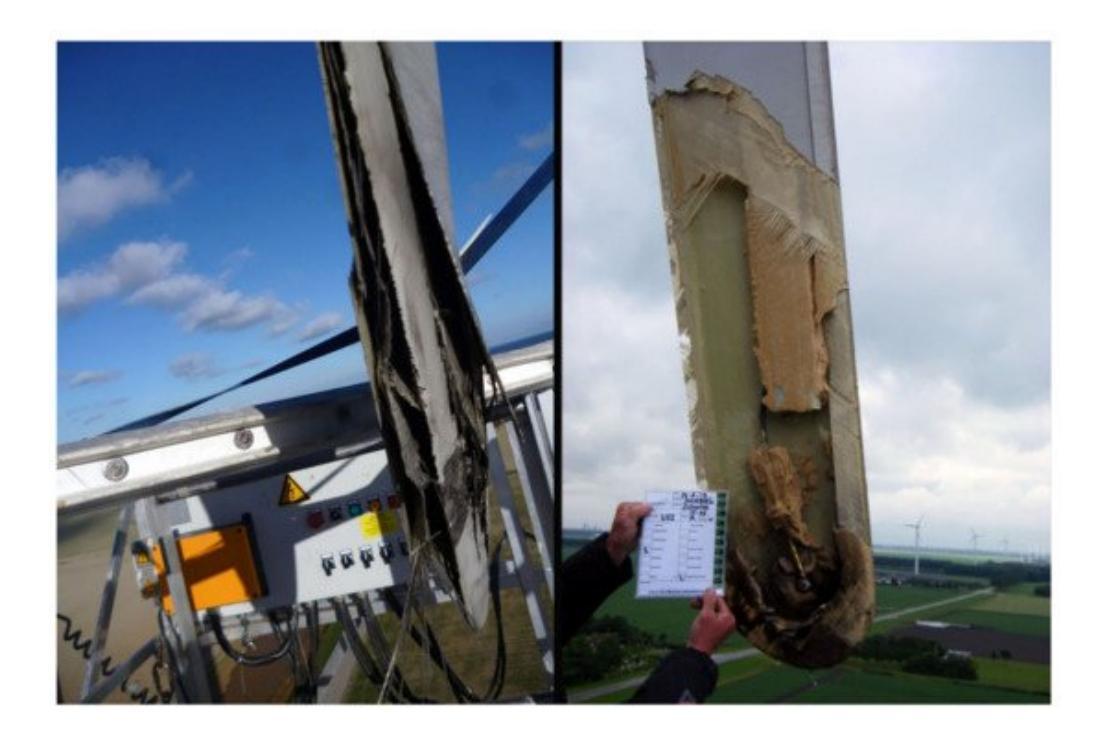
Shell detachment: The shell detachment consists of several meters of one or both shells completely detached from the load carrying structure (**Figure 3**). Usually, shell detachment starts with shell debonding. The mechanical forces generated by blades' rotation, alongside any flutter induced by the flow characteristics (which change due to the geometry change) and the strong wind gusts during adverse weather conditions, eventually lead to shell detachment. Shell detachment is a rather rare damage caused by lightning strikes on wind turbine blades. In cases of shell detachment, the lightning strike point is usually located within the last 3 m of the blade tip, even if the damage affects several meters of the shell.

Figure 3. Images of wind turbine blade shell detachment.

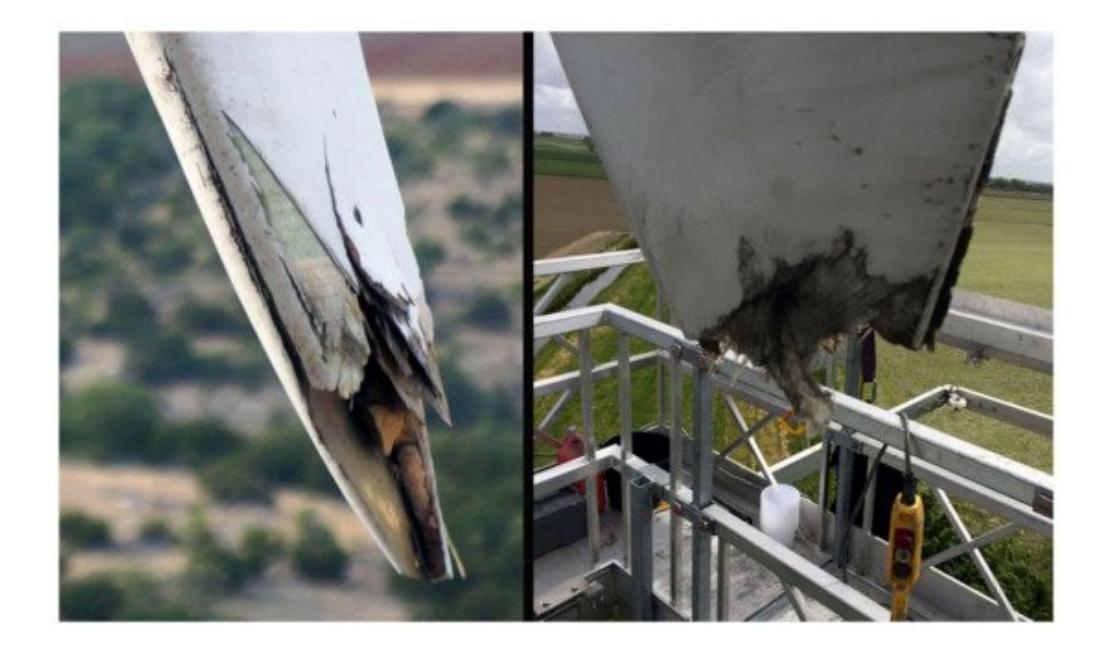
Tip detachment: Tip detachment refers to the complete detachment of several meters of the tip from the rest of the blade (**Figure 4**). It occurs when the lightning strike severely damages the structural laminate, such that the laminate cannot support the mechanical load and breaks. Consequently, tip detachment can be considered as the most critical case of WTB damage caused by lightning strikes. Tip detachment occurs rarely, most commonly in blades with a carbon fibre structure. For a 20 m blade length, tip detachment is located between 2 m and 7 m from the blade tip (namely, between 10% to 35% of the total blade's length), where a direct lightning strike can be critical for the integrity of the relatively thin laminate of the load carrying structure ^[20]. This type of damage occurs when the lightning current severely damages the structural laminate, to the extent that the laminate cannot support the mechanical load and breaks ^[21].

Figure 4. Typical images of wind turbine blade tip detachment, caused by lightning strikes.

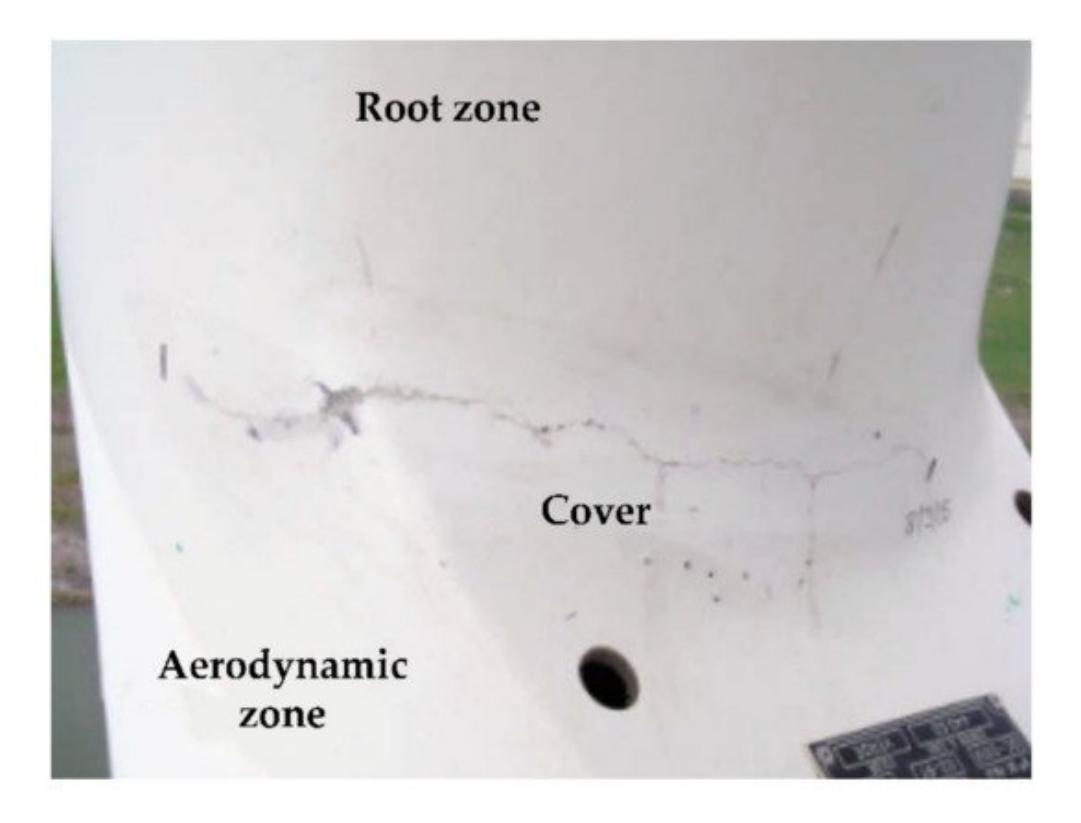
An image of typical fatigue damage in stage 1, in the form of cracks on the external surface, located in the transition zone between the root of the blade and the zone of airfoil profile, is presented in **Figure 7** ^[27].

Figure 7. Cracks in the hub joint area of a wind turbine blade due to fatigue ^[27].

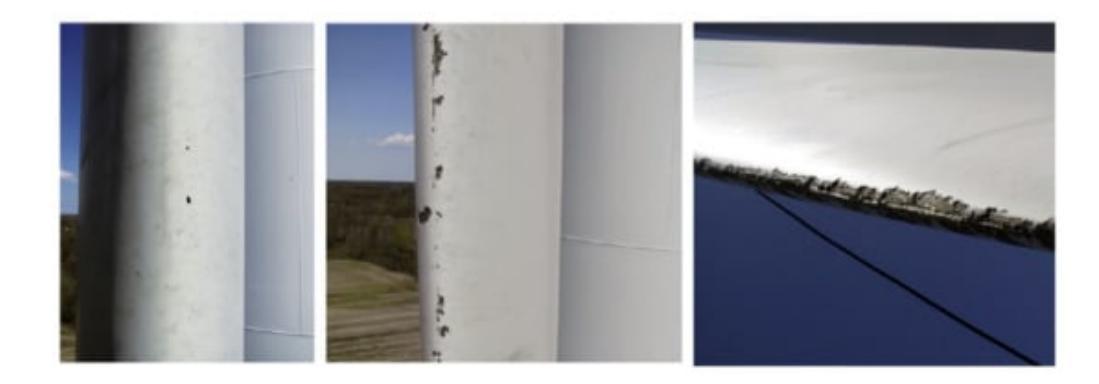
The first impact of this exposure is a gradual increase in the blade's surface roughness, which negatively affects the blade's aerodynamic performance by increasing its friction drag ^[30], and aerodynamic loss on the scale of 0.45–0.50% ^[31]. Depending on the level of leading edge erosion, drag can increase from 6 to 500% ^{[32][33]}, leading in turn to an approx. 5% reduction in annual electricity production. The reduced lift and increased drag become more intensive with higher levels of erosion ^[34]. In extreme cases of leading edge erosion, the structural integrity of the blade can be affected (**Figure 8**).

Figure 8. Examples of leading edge erosion [35].

Leading edge erosion can become an issue after only 2 years of turbine operation ^[31], much sooner than expected, with the tip being most susceptible to wear, but with erosion also exhibited on the more inboard portions of the blade ^[36]. As with all forms of environmental exposure, leading edge erosion is heavily site-dependent. In warm and arid climates, sand and dust may be a common type of airborne particulate and therefore may pose leading edge erosion problems, whereas in wetter, greener habitats, the problem may be non-existent. Likewise, at near-shore locations, the issue of sand erosion may be a considerable threat ^{[37][38][39][40]}. Leading edge erosion can be a result of rain, with the raindrops' kinetic energy, diameter, temperature and sea salt content being critical parameters ^[37]. It has been also observed that careful handling of the blade during manufacturing, transport and installation is essential to avoid small tears or scratches that may act as initiation sites for further wear and erosion ^[41].

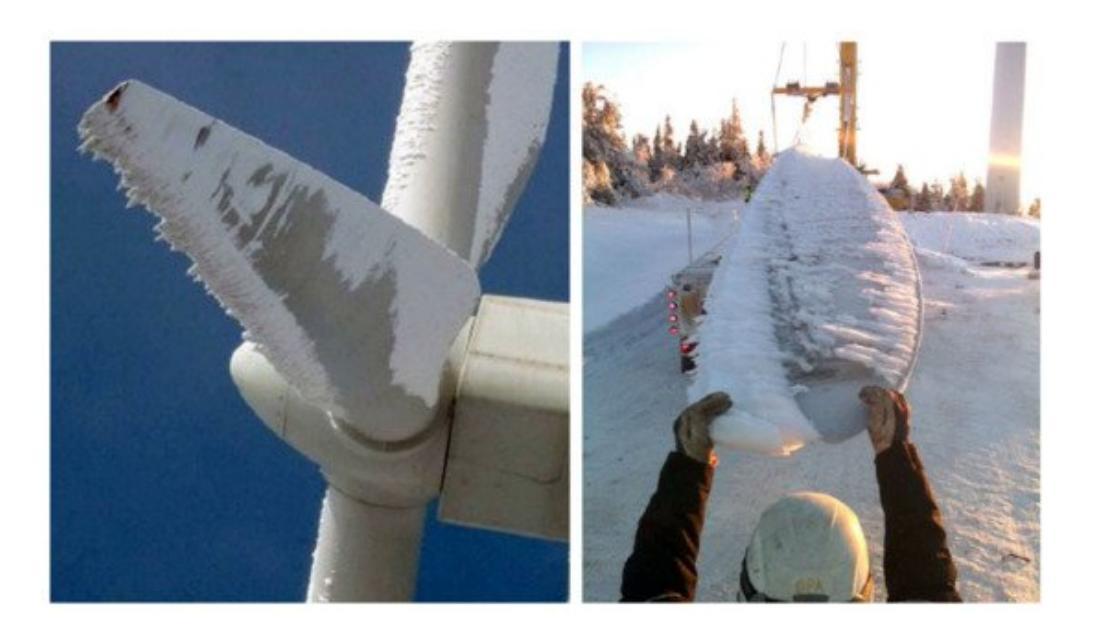
Ice accretion on the wind turbine blades produces significant change in the geometry of each blade's surface, affecting its aerodynamic efficiency. As a result, the blade lift reduces while the drag increases, resulting in reduced power production and, eventually, in the turbine's shutdown. Reduced power production occurs with an increasing number of lower than expected power stops, stops due to high vibration amplitude and stops due to faulty wind measurements.

Apart from the reduction in produced electricity, increasing vibrations and aerodynamic noise, imbalances in the blades, leading to increased wear in structural components such as connectors, couplers and gearbox, errors in nacelle wind speed measurements, as well as the risk of ice throw resulting in safety hazards should be expected as direct effects of icing ^{[53][54]} ^{[55][56]}. Symmetrical icing of the blades reduces loads acting on the turbine components, whereas asymmetrical icing of the blades induces loads and vibrations in the tower, hub and nacelle assembly at a frequency synchronous to rotational speed of the turbine ^[55], imposing considerable fatigue loads. The aerodynamic changes in the iced blade can cause violent vibrations within the wind velocity operating range of the turbine ^[56]. Indirect consequences from the above effects might include reduced technical life, bodily injuries and material damage caused by falling ice.

Figure 10. Ice on wind turbine blades [50][57].

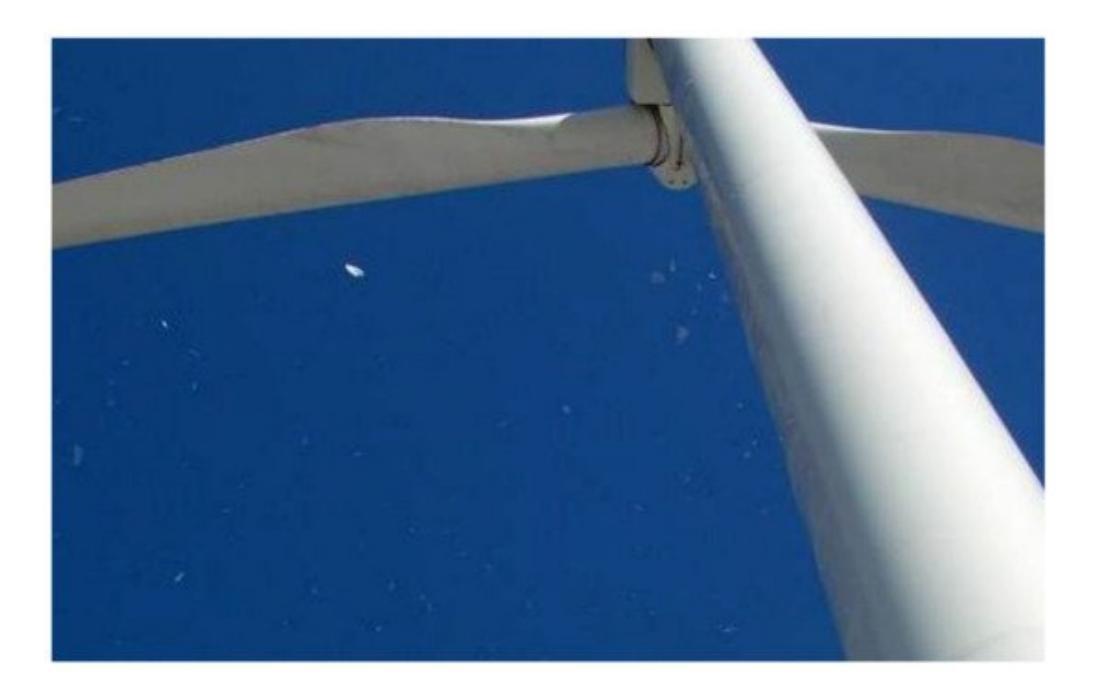
Iced up wind turbines blades and towers can pose a safety risk for wind parks visitors and staff, as large pieces of ice may be thrown from turbine blades during operation. **Figure 11** is provided as an example of falling ice fragments ^[49].

Figure 11. Ice falling or being thrown off a wind turbine poses a safety risk to turbine maintenance staff and, depending on turbine siting, the general public ^[50].
