Stone Construction Materials of the Vera Cruz Church

As part of the restoration project of the 13th century Vera Cruz Church (Segovia, Spain), a preliminary study of the stones used in its construction—dolostones of the Montejo de la Vega Fm of Santonian age (Upper Cretaceous)—and the possible location of the quarry of the provenance of these stones was carried out. For this purpose, a comparative analysis was performed between the currently active quarry of La Vera Cruz n° 88 and the historical quarry of Zamarramala. The samples were characterized using a multidisciplinary approach, combining X-ray diffraction (XRD), polarized optical microscopy (POM), and scanning electron microscopy with microanalysis (SEM-EDX).

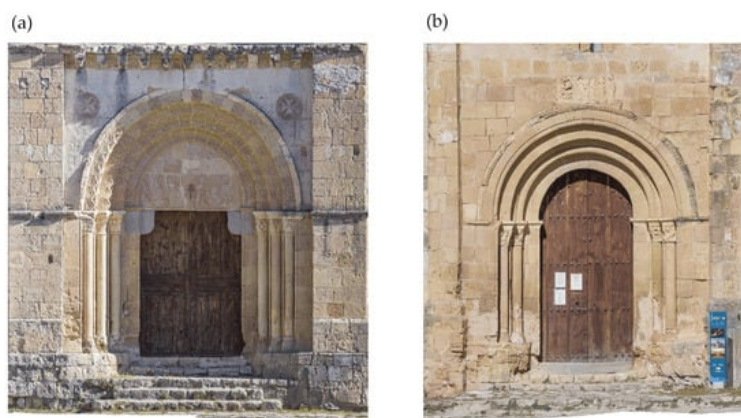
Figure 2. Church façades: (a) West doorway; (b) South doorway. Orthoimages: Luis-Javier Sánchez-Aparicio.

The west doorway (**Figure 2a**) consists of three pairs of columns topped with capitals and archivolts (a set of arches inscribed on top of each other to form a flared doorway). The first arch is only decorated with a thick architrave on its edge and rests on the doorjambes [11]. Men, birds, and demons embellish the capitals of the six columns. Chevron ornaments adorn the upper and lower parts of the archivolts [12]. The archivolt, which closes the whole, is decorated with a fine square billet (chequers) molding. All of them are framed by a horizontal impost of carved corbels. The carving is very fine and graceful, as Cabello y Doderó points out. The stone used for the doorways is better suited to the needs of a more precise, better quality carving, as it is finer-grained.

The south doorway (**Figure 2b**) is also flared but has only two pairs of semicircular archivolts. These are surmounted by a chequer molding as well. In this doorway, the work on the archivolts and capitals is simpler and the decoration is much less elaborate. Above this door is a bas-relief that was described in the report of the Royal Academy of Fine Arts of San Fernando. It had already deteriorated in 1919, but it was possible to identify a seated monarch or a judge in the act of administering justice on the left side, three standing women on the right, and a tree in the center [4].

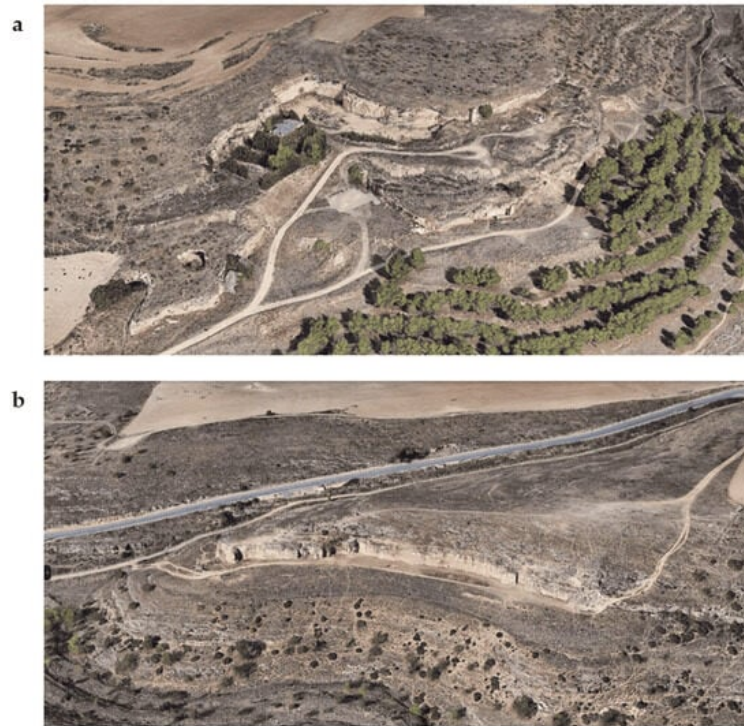
Figure 4. (a) Active quarry of Vera Cruz n° 88. (b) Historical quarry of Zamarramala. Source: Google Earth [30].

Parral dolostone is quarried at 'Vera Cruz n° 88' (**Figure 4a**), which is still active today, and could be used for the reconstruction of elements in the church. It is an open-cast quarry, although there are traces of underground mining. The terraces are about 10 m high on a slope front about 100 m long [24]. The stone, soft and porous, is suitable for building (**Table 1**). It is possible that the stones in Vera Cruz come from different strata and quarry faces.

As for the Zamarramala quarry (Figure 4b), it is also an open-cast quarry with traces of underground extraction and with better-quality fronts [24]. It was exploited in search of a stone with a finer grain size and lighter color, considered to be of better quality for carving.

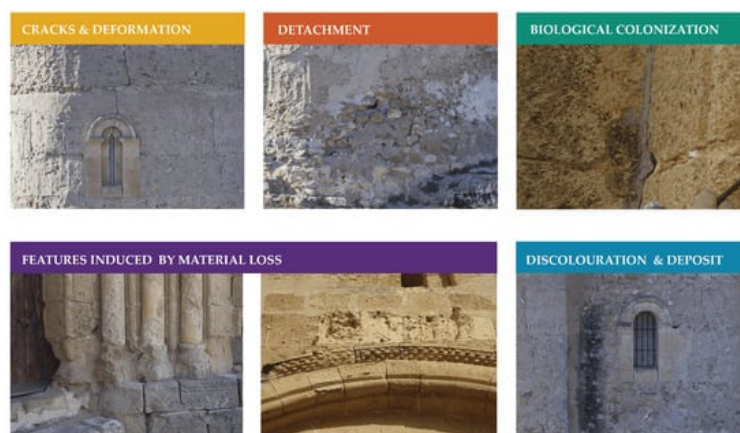
Figure 5. Stone weathering following ICOMOS terminology.

Following the terminology proposed by ICOMOS [31], alterations are identified in all the categories described in the Glossary, as visually illustrated in Figure 5.

Fracture-type cracks are observed in the masonry and are particularly evident in the apses (west façade) and interior vaults. As a result of the accumulation of water and unfortunate interventions, detachments in the form of fragmentation

can be seen in the base area and in the masonry.

The predominant alteration observed in the monument is material loss. There is pitting (unconnected cavities) in the contact zones between the granite steps and the dolostone on the south façade ^[22]. In addition, interconnected cavities in the form of alveolization are prevalent. Discoloration and deposits associated with damp conditions are particularly concentrated on the base and roof, giving rise to efflorescence and soiling.

Biological colonization of spores within dolostone pores causes cracking upon germination. Low intracrystalline porosity potentially hinders fungal penetration into the crystal, so they are located in spaces between dolomitic crystals. Fungi are predominantly associated with altered zones, both on the surface and in the interior ^[27]. In addition, plants are also found on the outer walls.
