Seismic Rehabilitation Techniques for Cultural Heritage

Keywords: masonry buildings ; authenticity ; improvement ; seismic strengthening ; historic urban space ; sustainable management

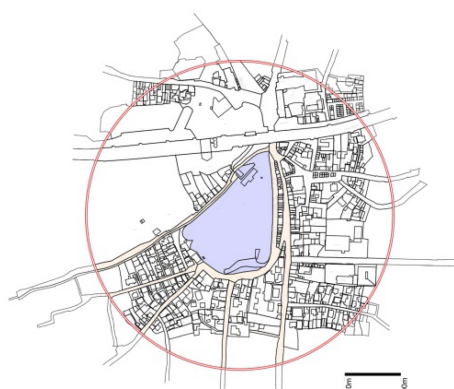
Figure 1. Aerial view of the City Fortress. (a) Position of the fortress in Novi Pazar (photo source Geo Serbia); (b) City Fortress (drawing design: Lejla Zećirović).

The Novi Pazar Fortress is a medieval Turkish fort, built by Isa-bey Isakhovic in the 15th century when the city itself was established, at the crossroads of caravan routes that connected Bosnia, Dubrovnik, and the southern Adriatic with Constantinople and Thessaloniki. It is located in the city center, on the right bank of the Raska River, likewise covering the area of the city park. The fortification consists of three angular bastions—Tabias (original oriental word) and a tower known as the Stara izvidnica (Reconnaissance Tower), or Tower Motrilja (Watchtower) located between the northern and western Tabias. Tower Motrilja and northern Tabia were connected by a stone wall representing the only visible remnant of this kind of defensive walls [6]. Based on the remains of ramparts, Tabias, and half-buried ditches, it was established that the fortress had a triangular base formed by three corner Tabias, with a polygonal base of different dimensions (**Figure 1** and **Figure 2**).

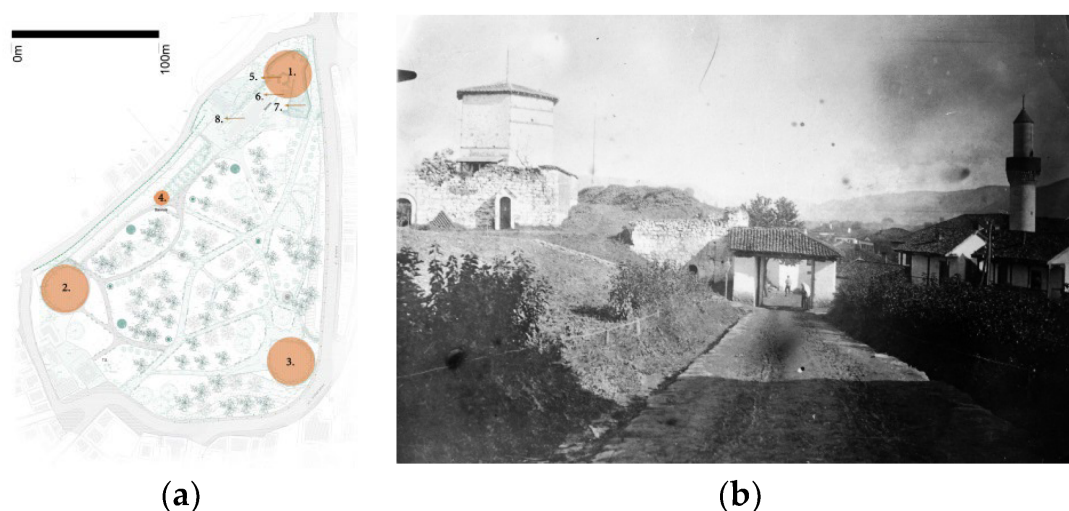
Figure 2. Details of city fortress. (a) Scheme of the facilities of the City Fortress—Actual state: 1—Northern Tabia; 2—Western Tabia; 3—Southern Tabia; 4—Tower Motrilja; 5—Tower Dzephana; 6—Gunpowder tower—Bartuthana; 7—Zindan; 8—Modern-day Library. (Drawing design: Lejla Zećirović). (b) Entrance into the Fortress (Photo source: Tower Dzephana, 1916, private archive of Vladan Vidosavljević).

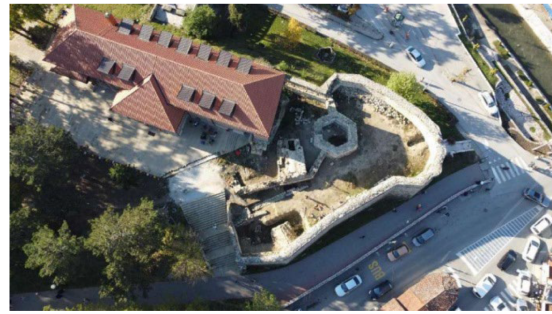
Figure 3. Northern Tabia (a) Tower Motrilja (Photo and design: Lejla Zečirović). (b) Modern-day City Library (Photo source: private archive of Vladan Vidosavljević).

The fortress is located in the very center of the city of Novi Pazar, on the right bank of the Raska river, elevated in relation to its bed and within the city park. The fortress is connected to the oldest part of Novi Pazar, surrounded by the Old Bazaar on the east, residential quarters on the southwest and a gap (now a promenade) on the northwest side. The fortress occupies an area of about two hectares, the inner space of which is used as a city park. Through the park, there is a lively pedestrian connection between the center and the parts of the city where there are residential areas, the hospital and the stadium. As already said, the fortification consists of three corner Tabias, which are arranged in the vertices of an approximately isosceles triangle, with the top pointing north, and a tower known as Tower Motrilja located between the Northern and Western Tabia [11]. A stone rampart connects the Tower Motrilja and the Northern Tabia (Figure 3), representing the only visible remain of this type of defensive walls.

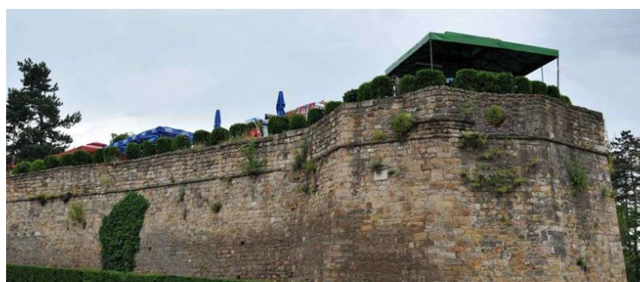
Figure 5. Northern Tabia. (a) North-south view (Photo source: private archive of Vladan Vidosavljević). (b) Eastern view (Photo source: private archive of Vladan Vidosavljević).

Tabias were the main elements of defense, according to the principles of artillery fortifications (Figure 5, Figure 6 and Figure 7).

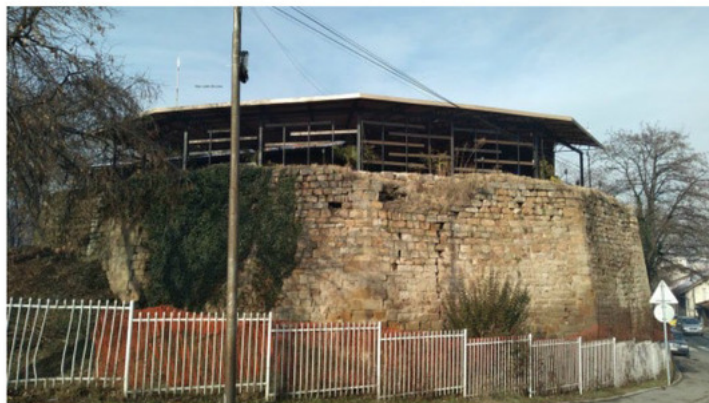
Figure 6. Southern Tabia: SW-NW view (Photo source: Lejla Zečirović).

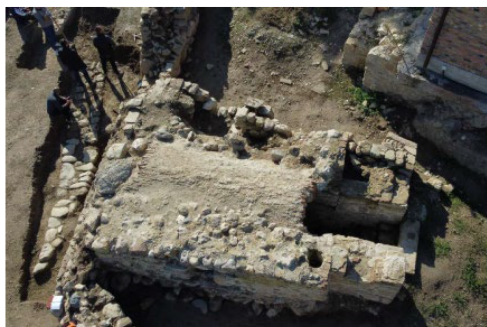
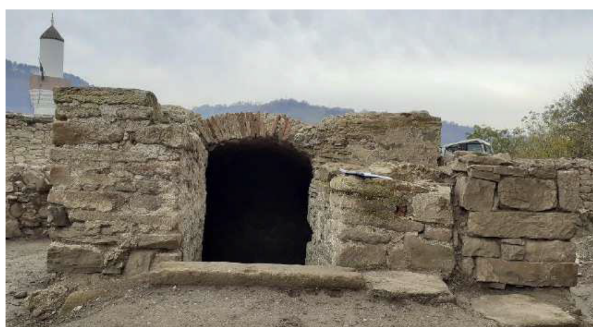
The Baruthana was the facility for storing gunpowder. It was recently discovered next to the remains of the Tower Dzephana. The facility is preserved, but the exact time of its construction is still unknown (**Figure 9**).

Figure 9. Baruthana. (a) Archeological site aerial view, (b) Baruthana entrance portal—view from outside (Photo source: private archive of Vladan Vidosavljević).

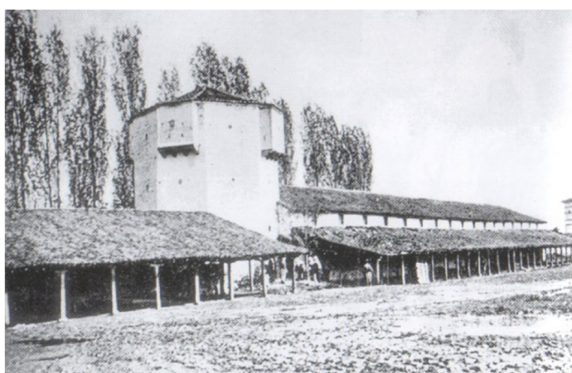
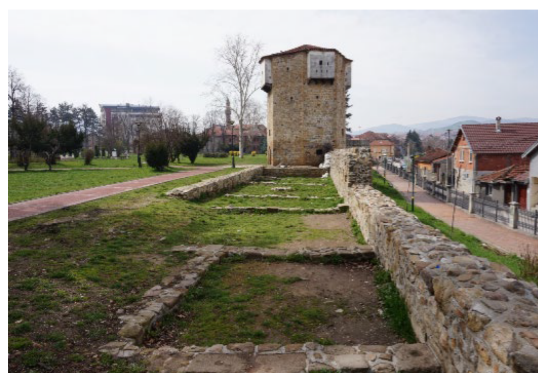
Figure 10. Tower Motrilja. (a) Archive photo—Tower Motrilja in 1918 (Photo source: private archive of Vladan Vidosavljević). (b) Present state of the tower with the remains of the Turkish barracks from the period of Abdul Aziz's reign (Photo source: private archive of Vladan Vidosavljević).

Of the numerous objects that were in the fortress, only Tower Motrilja or Sejir Kula (local name) has been preserved, an architecturally well-designed and shaped building with an octagonal base from which high walls were raised (**Figure 10a**). It served as an observation post with a wide field of vision to secure the ramparts from potential attackers. The tower is located between the northern and western Tabias, it is about 15 m high, and in the upper zone of the walls there are four musharabiyas (Turkism, loopholes), circular loopholes of smaller dimensions as well as some rectangular ones (**Figure 10b**).

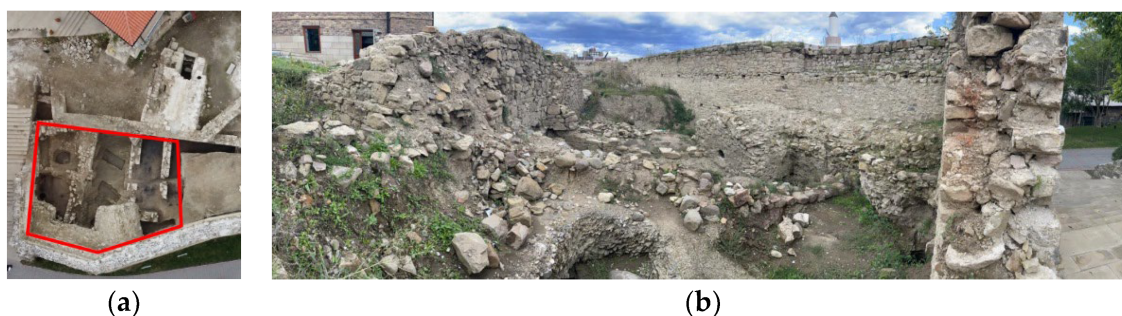
Figure 11. Excavation of the dungeon. (a) Aerial view of the site. (b) Present state of the remains of the dungeon (Photo source: Lejla Zečirović).

The archaeological excavation conducted in 2020 revealed the following: The walls of the dungeon (zindan, Turkism), and the corridor leading to it are not structurally connected to the walls of the Tabia, which were not built at the same time ^[42]. From the outside, the dungeon shows several construction interventions during different time phases (**Figure 11**). The northwest corner of the entrance to the dungeon has been rebuilt, as well as its entire western wall, which can also be seen from the inside. The outer sides of the dungeon walls are rather crudely executed. The walls were made of broken

and hewn blocks of sandstone, river pebbles, and bricks connected with lime mortar. The binding material was lime mortar. The space between the walls of the dungeon and the western and northern profiles was filled with a large amount of cinders and ashes as well as burnt fragments of bricks and roof tiles, which testifies that the building was destroyed by fire. The floor was most likely made of lime plaster, but it was completely burnt and its appearance is preserved to a lesser extent on the inner side of the south wall.

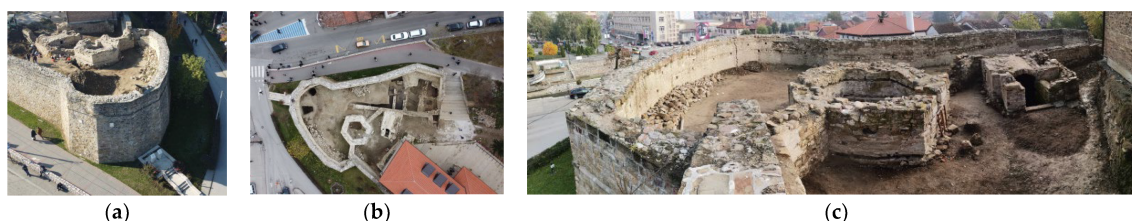
Figure 12. The remains of the tower Dzephana found on the northern Tabia, next to the dungeon. (a) NE-SW view; (b) aerial view; (c) on-site view (Photo source: private archive of Vladan Vidosavljević).

The Tower Dzephana is a hexagonal building of smaller dimensions at the base, next to the northern Tabia of the fortress. Based on the remains (Figure 12) found by archaeologists from Novi Pazar, Sjenica, Belgrade, and Sarajevo, this hexagonal tower was built at the beginning of the 17th century, and not, as previously thought, in the 18th century (based on written documents) [12].

The entrance to the tower was located inside the southwestern wall and was 0.70 m wide. The tower was built from hewn blocks of sandstone and trachyte and river pebbles bound with lime mortar, and the filling consisted of pieces of sand and trachyte, river pebbles and fragments of bricks with lime mortar. The structure of the walls was strengthened by placing wooden beams in the walls of a rectangular cross-section, along with semi-shaped beams connected with iron wedges which were placed transversely in relation to the walls. The outer walls of the tower were plastered and painted, and the inner walls were only plastered. Two phases are visible on the floor surface of the tower, the younger lime mortar and the older stone slabs. The foundations of the tower were made of river pebbles arranged in a regular sequence in four rows and flattened from the outside in relation to the walls. The height of the foundation of the tower is about 1.00 m.

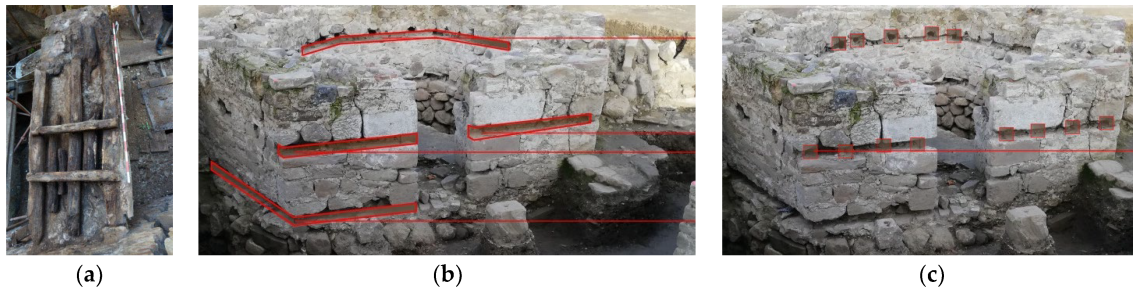
Figure 13. The remains of the tower Dzephana. (a) Wooden construction for reinforcement (from Hilandar monastery, identical to the construction of Tower Dzephana). (b) Molds of the longitudinal beams on Tower Dzephana. (c) Molds of the transversal beams on Tower Dzephana (Photo source: private archive of Vladan Vidosavljević).

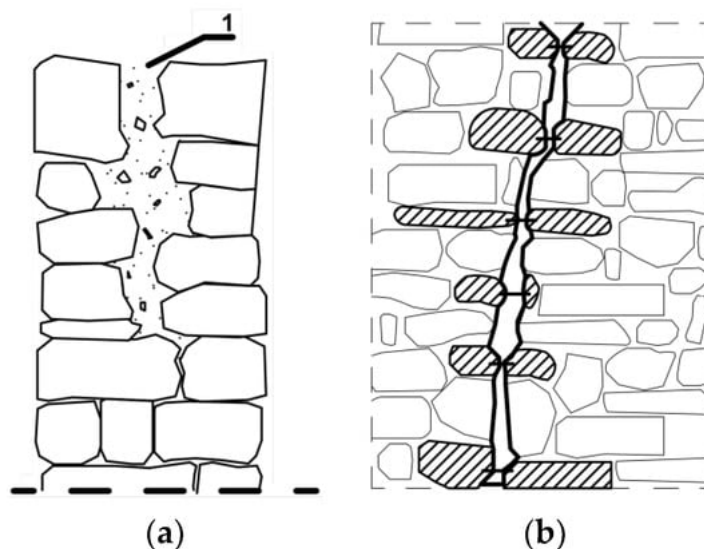
Figure 14. Technical details: (a) Stone wall with points of mortar injections. (b) Clamps or fittings perpendicular to the cracks in the wall (Drawings: Lejla Zečirović).

Injection mortars can have different ingredients, depending on the dimensions of the cracks and fissures, that is, on the dimensions of the opening that is filled with the injection mass. The following can be used for grouting: epoxy resins, cement suspensions, cement mortars, polymer-cement mortars, and epoxy mortars. Quartz flour is most often used as a filler in the mentioned mortars. Finely divided mineral materials (bentonite—a kind of clay of volcanic ash, natural and artificial pozzolans, used as a filler) are used as additives for making injection mixtures, and plasticizers and aerants (air entraining admixture) are used as chemical additives. Epoxy resins are used for injecting cracks up to 0.3 mm wide. Other types of injection mortars are used for injection of cracks wider than 0.3 mm, cavities, injection of prestressing cables, etc. (**Figure 14a**). Cracks wider than 0.3 mm can be filled by injecting liquid cement mortar, and in special cases epoxy materials are used. Injection of cracks can be omitted if the reinforcement of the shotcrete wall planned to be done by injection of water-cement mortar in nozzles, under pressure. Injection can also be used for larger cracks up to a size of 10 mm. The injection procedure is carried out step by step: first, the plaster around the crack is removed, using a jet of water or pressurized air. Then along the crack, at lengths of 300 to 600 mm, holes are drilled into which plastic tubes are placed at a depth of 50 mm, fixed with cement mortar. Cracks are filled with cement mortar along the entire length. The tubes are plugged and then, by opening the plugs in pairs, the crack between the adjacent tubes is washed or blown out. Injecting is done under low pressure, from the bottom up, and the emulsion starts to flow on the first upper tube [36]. Instead of tubes, the grouted wall can be strengthened by inserting clamps at the grouted places (**Figure 14b**).

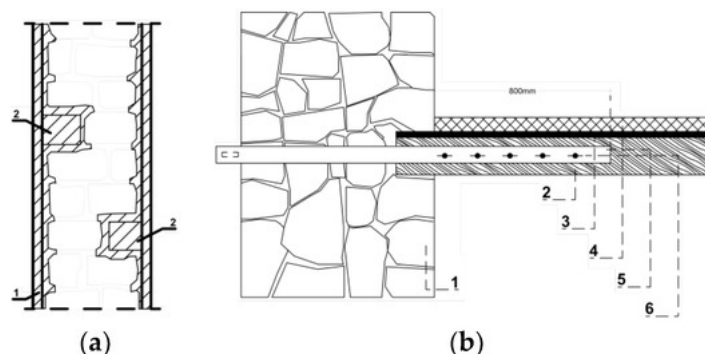
Figure 15. Technical details: (a) 1—Reinforcement with the reinforced cladding; 2—connection with the wall by concrete “niches”; (b) connection of a wooden mezzanine structure to a stone wall: 1—existing stone wall; 2—existing wooden beam; 3—wooden mat; 4—new cement screed; 5—steel strip; 6—elsers (Drawings: Lejla Zečirović).

of better quality or reinforced with ring beams ^[41]. Part of the facade can be connected to the rest of the building, using wooden beams—tensioners and iron anchors, so-called “keys” (**Figure 15b**). In this way, during an earthquake, due to stress concentration, the creation of cracks and the collapse of the walls would be prevented. Blocks of stone can be connected to each other with metal anchors, in order to act on the principle of a chain ^[37].
