Roman Houses of Armea (Allariz, Ourense)

Francisco Conde-Valvís's so-called "stone treasure" is a set of unique carved stone pieces, such as bases, column shafts, a mortar, and decorated fragments (trisqueles and rosettes), found during the 2018 excavation campaign in the Cibdá de Armea (Allariz, Ourense). They had been piled up and re-buried—no records existed as to where—at the western end of the Finca de A Atalaia, which was excavated in the 1950s under the direction of Conde-Valvís and began to be excavated again in 2011.

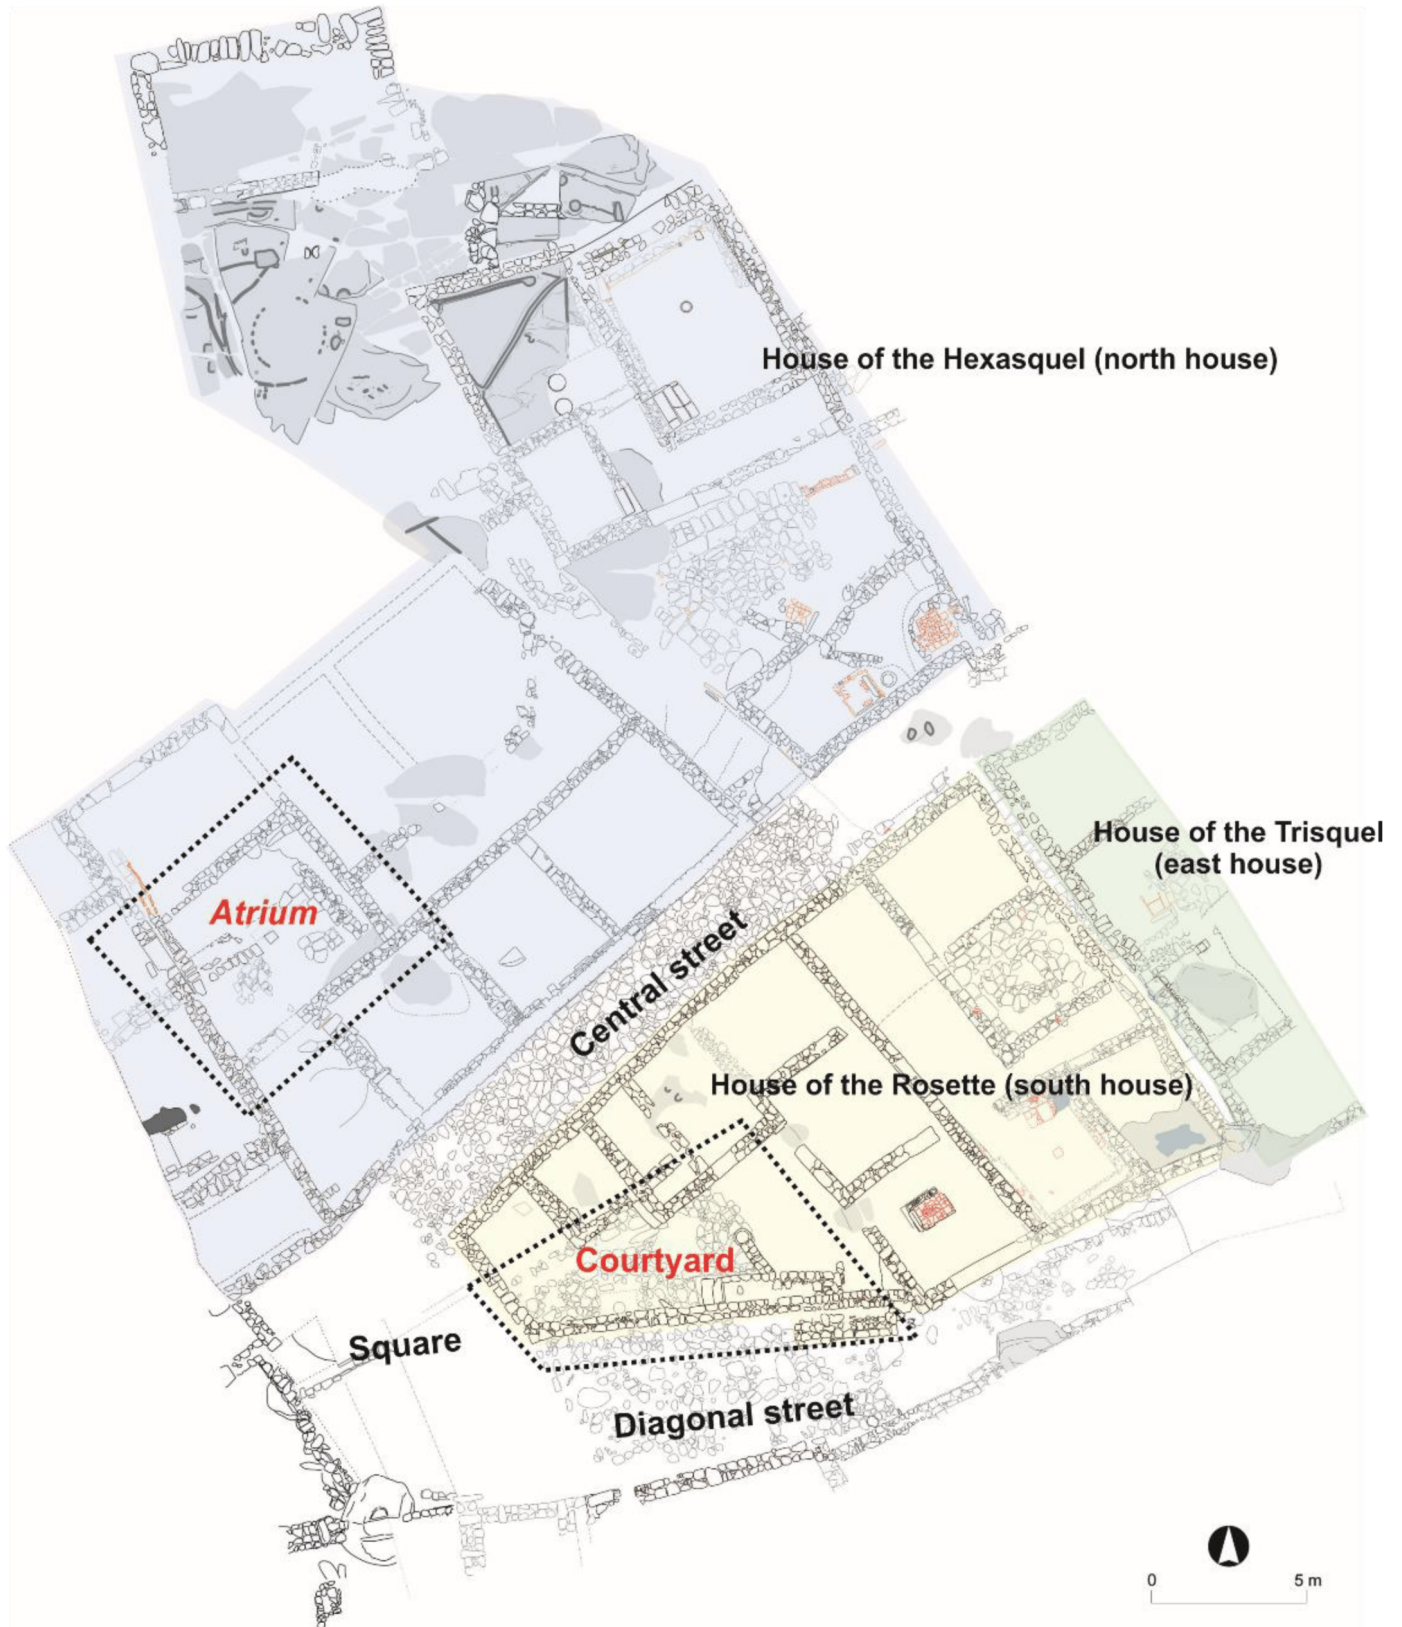
Figure 3. Plan of the excavated Roman settlement in A Atalaia.

Cibdá de Armea is situated on the hill's northern slope. In the 1950s, a series of Roman courtyard houses were excavated in a terrace known as A Atalaia, flanking a stone-paved street ^[9]. Systematic excavation of this area was resumed in 2011. Initially, the excavation focused on re-excavating the 1950s trenches, but from 2014, the stratigraphic excavation of new areas began under the direction of a team from the University of Vigo. To date, this has resulted in the full excavation of two atrium houses and the partial excavation of another one. This house type is rare in Roman sites in rural contexts in northwest Spain (**Figure 3**). One of the earliest occupation phases, from the late 1st to the late 2nd or early 3rd centuries AD, was eminently Roman in character. Thus far, the stratigraphy suggests that there is a hiatus in occupation between the Late Roman and the Late Medieval period. An earlier occupation phase (early to late 1st century AD) has been attested in A Atalaia, which is coetaneous to the construction of Monte do Señoríño ^[10], as revealed by the ceramic record—Italic and south-Gallic *terra sigillata*, Baetican amphorae, indigenous wares—and razed architectural features under the large houses ^{[7][11]}. The analysis of the ceramic contexts found during the recent excavations has allowed to outline the occupation sequence of Armea ^{[7][11]}. Everything suggests that this terrace was first occupied in the early 1st century AD, contemporaneously to the construction of the area of O Señoríño on the site's outskirts ^[5]. Evidence for this period includes a series of domestic and industrial (metal smelting) features found under the house of the Hexasquel and the main thoroughfare, which have been dated, based on the ceramic assemblage, to the final years of Augustus's

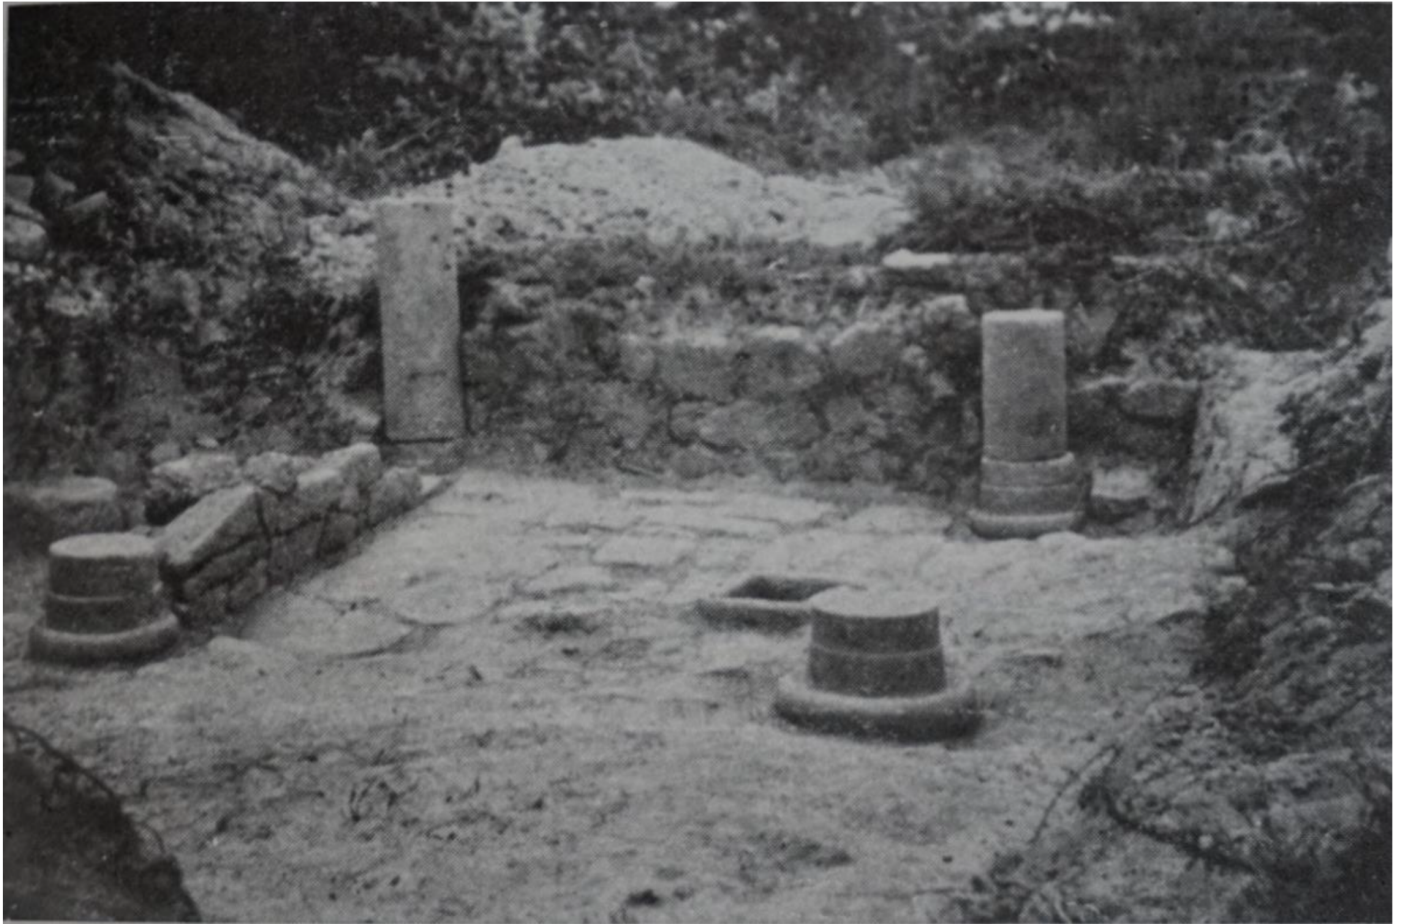
Figure 4. Photograph of the atrium after the excavation (Conde-Valvís 1959: Plate I).

Conde-Valvís ^[9] (pp. 479–483) describes an atrium with four column bases at its centre, forming a perfect square with 2.5 m sides (**Figure 4** and **Figure 5**). He also found two column shaft fragments among the debris, which Valvís placed over the bases, somewhat randomly, to take a picture of the courtyard. It has been impossible to establish whether a capital was also found, as the text is unclear in this regard. Although at first he writes that none of the four capitals were found, it was claimed that three of the four capitals were missing, so this suggests that at least one of them was found. The atrium was paved with small, unevenly sized, stone slabs, and a channel ran across the room from E to W; a square drain, similar to that which is still visible in the southern domus, was also identified. Conde-Valvís uses the terms *impluvium* and *compluvium* incorrectly. He refers to the square drains in the atrium and the courtyards of both houses as *compluvium* and to the paved areas as *impluvium*. Interpreting this small drain, used to evacuate rainwater, as a *compluvium* is a mistake, for *compluvia* are the openings left on the roofs of atria to let in light and air, as well as to let rainwater fill the *impluvium*, a pool from which water ran into the house’s waterpipe system. In Armea, rainwater entered through this opening, which can be regarded as a *compluvium*, but not into an *impluvium*, but directly onto the paved floor. Rainwater filtered through the stone slabs and was channelled to the rest of the house through the quadrangular drain and a stone channel built beneath the pavement.

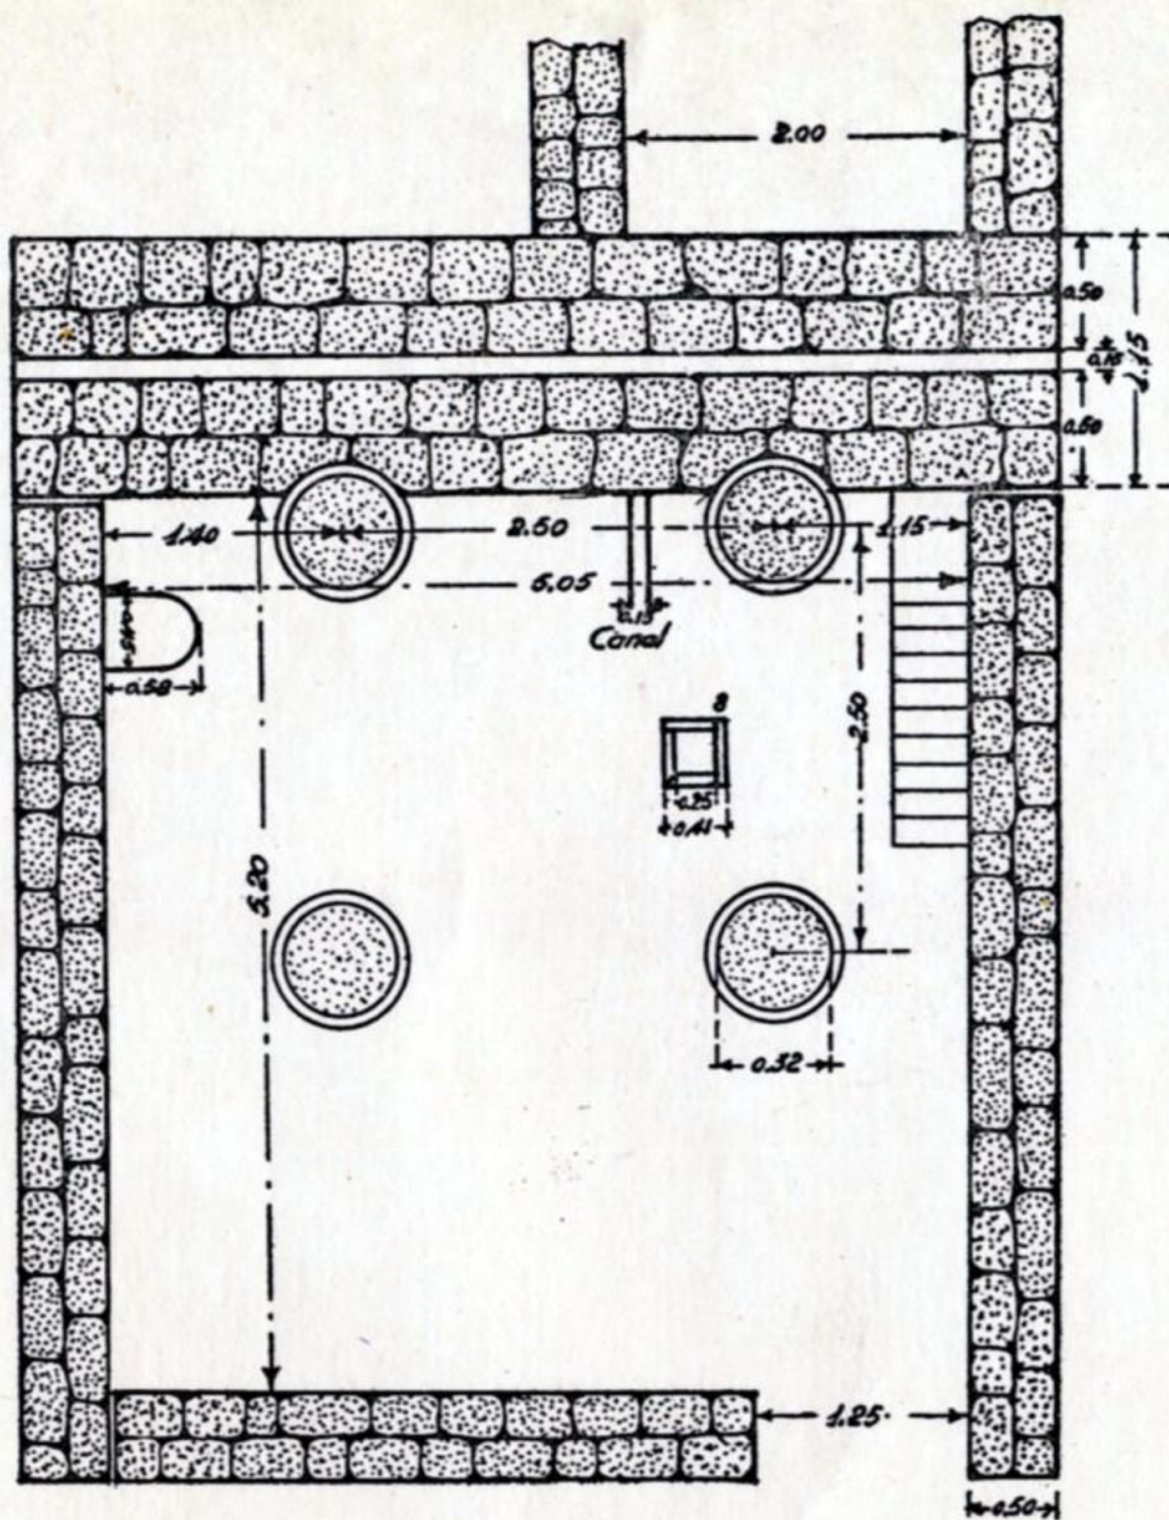
– Plano del «atrium» de la villa N.º 1.

Figure 5. Plan drawn by Conde-Valvís in 1955 (Conde-Valvís 1959: 482).

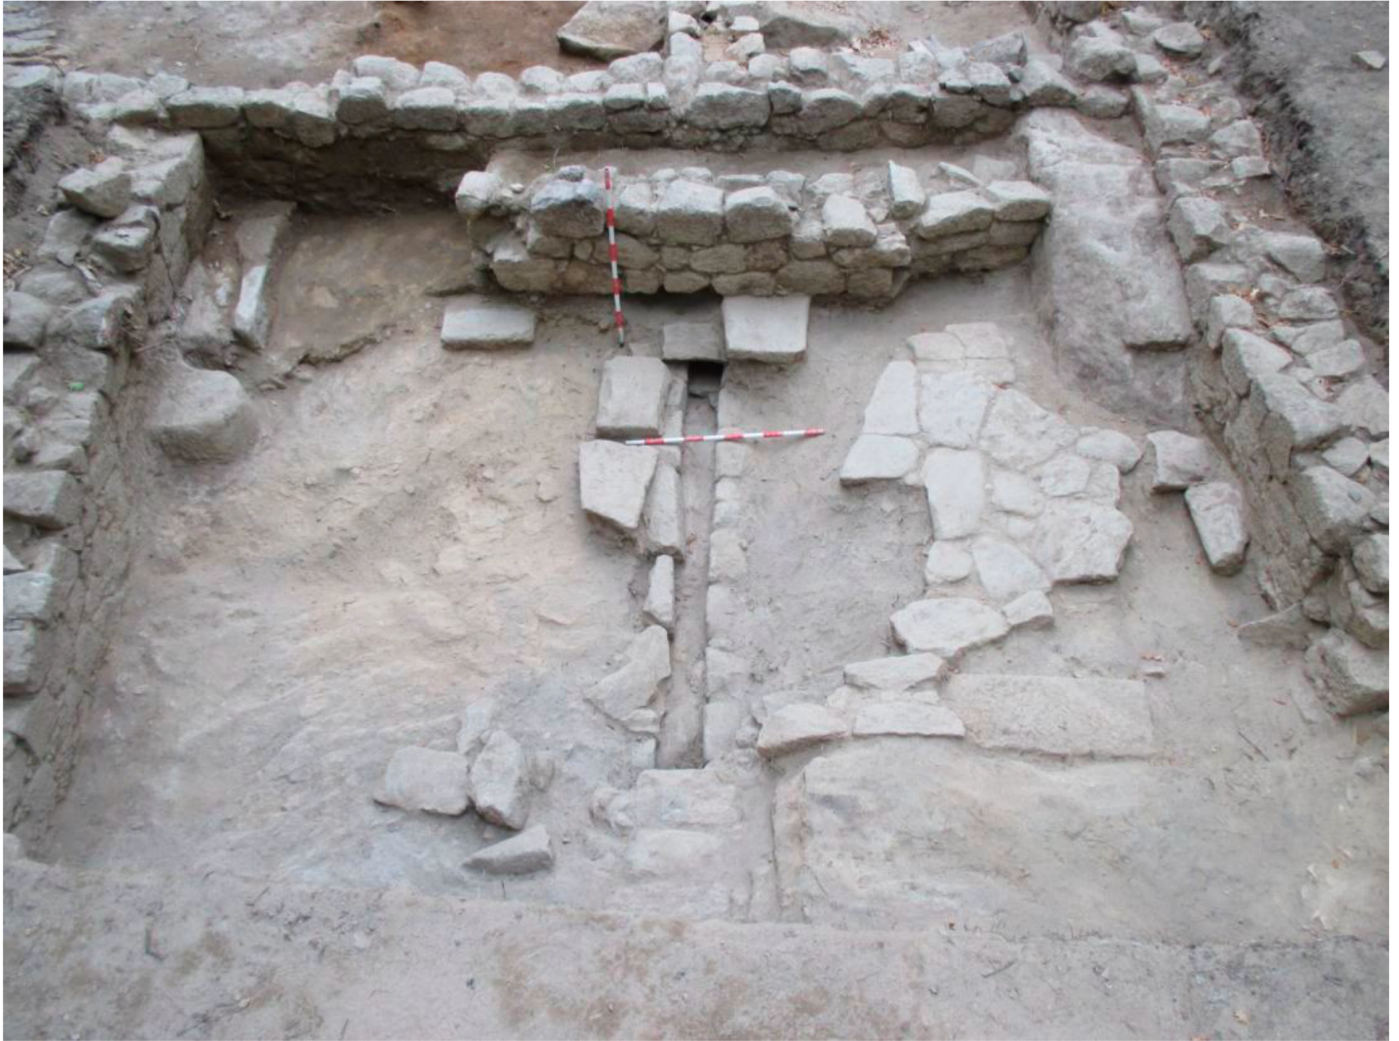
Figure 6. State of the courtyard after the 2014 excavation. Photograph: David Pérez.

The consolidation and musealisation works in 2018 included raising the walls by adding a few protective courses and the restitution of part of the pavement and the drain lids, using slabs found among the fills that covered the rooms (**Figure 6** and **Figure 7**). Additionally, in the words of the director of the excavations, “In order to present a discourse that is closer to reality, two fragments of Roman columns found in the vicinity were placed on the bases, conveying an image that helps to reflect the archaeological discourse” ^[13] (pp. 89–90). After consulting some of the archaeologists, it was concluded that the original location of these column shafts cannot be established with any certainty, and that it is not even clear that they belong to Armea. They were brought to the site in 2014 from the house where they were found out of context in Allariz’s historical quarters. The analysis of their raw material (granite), morphology and typology, and their comparison with other columns found in the archaeological context in Armea, strongly suggest that they are foreign to the Cibdá, and they cannot even be securely dated to the Roman period to which the site is dated. Following this, it was decided to remove these columns, especially after the original column shafts were found in “Conde-Valvís’s stone hoard”.

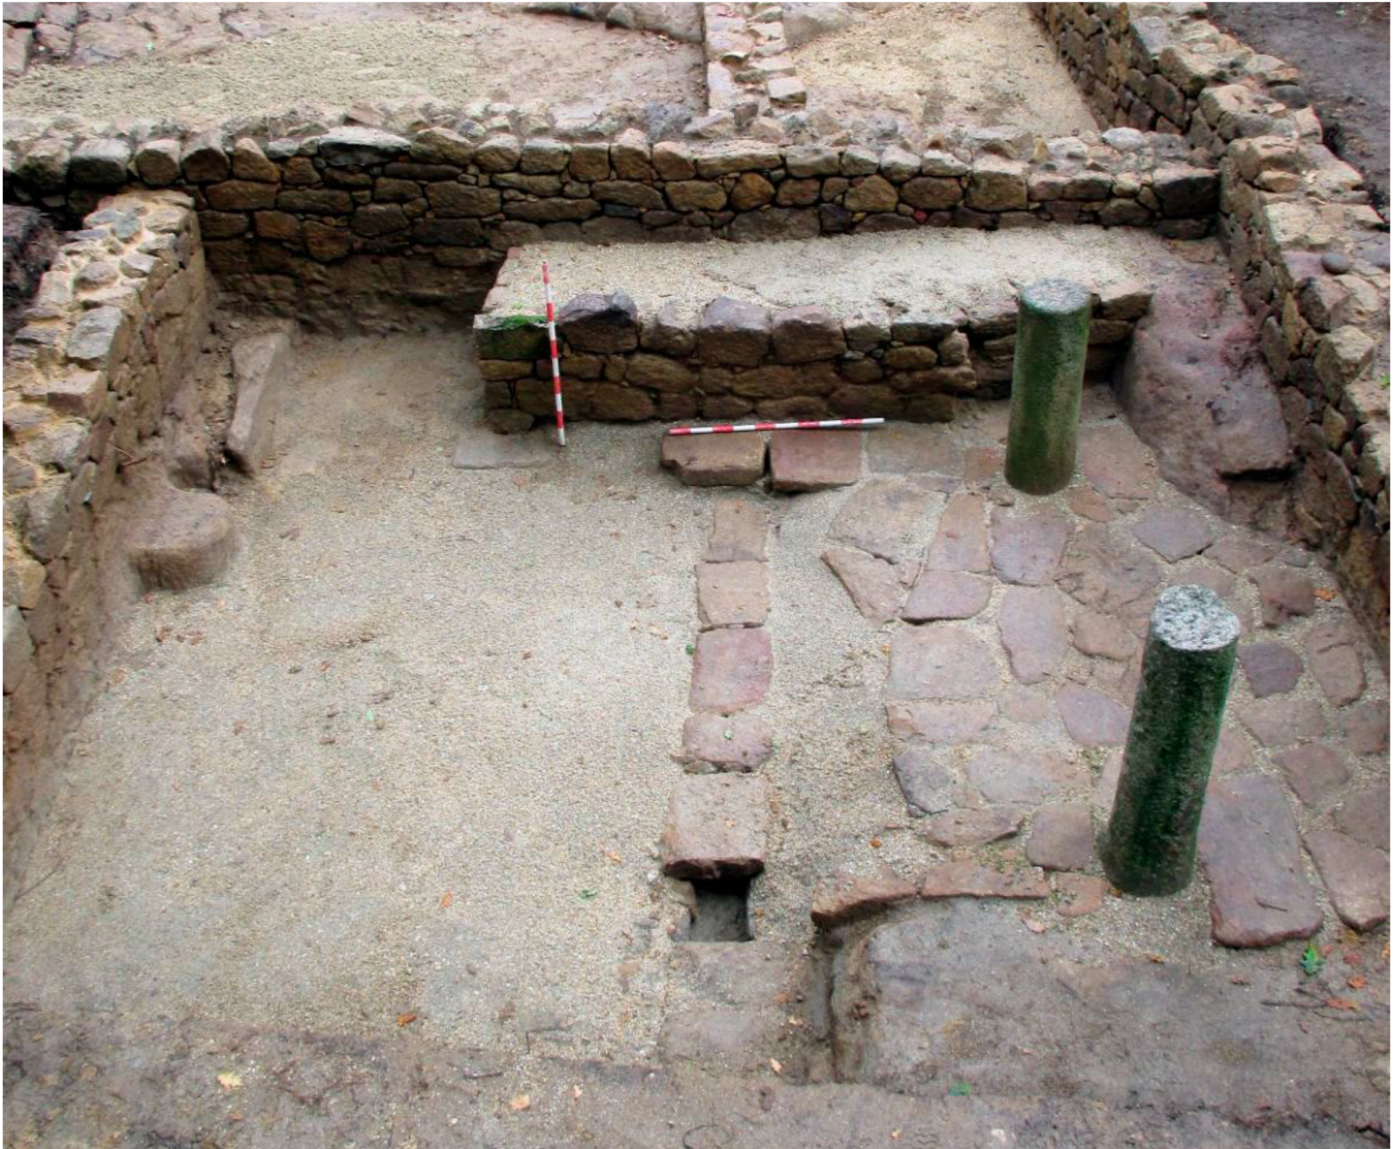
Figure 7. Final state of the atrium after the restoration works in 2014. Photograph: David Pérez.

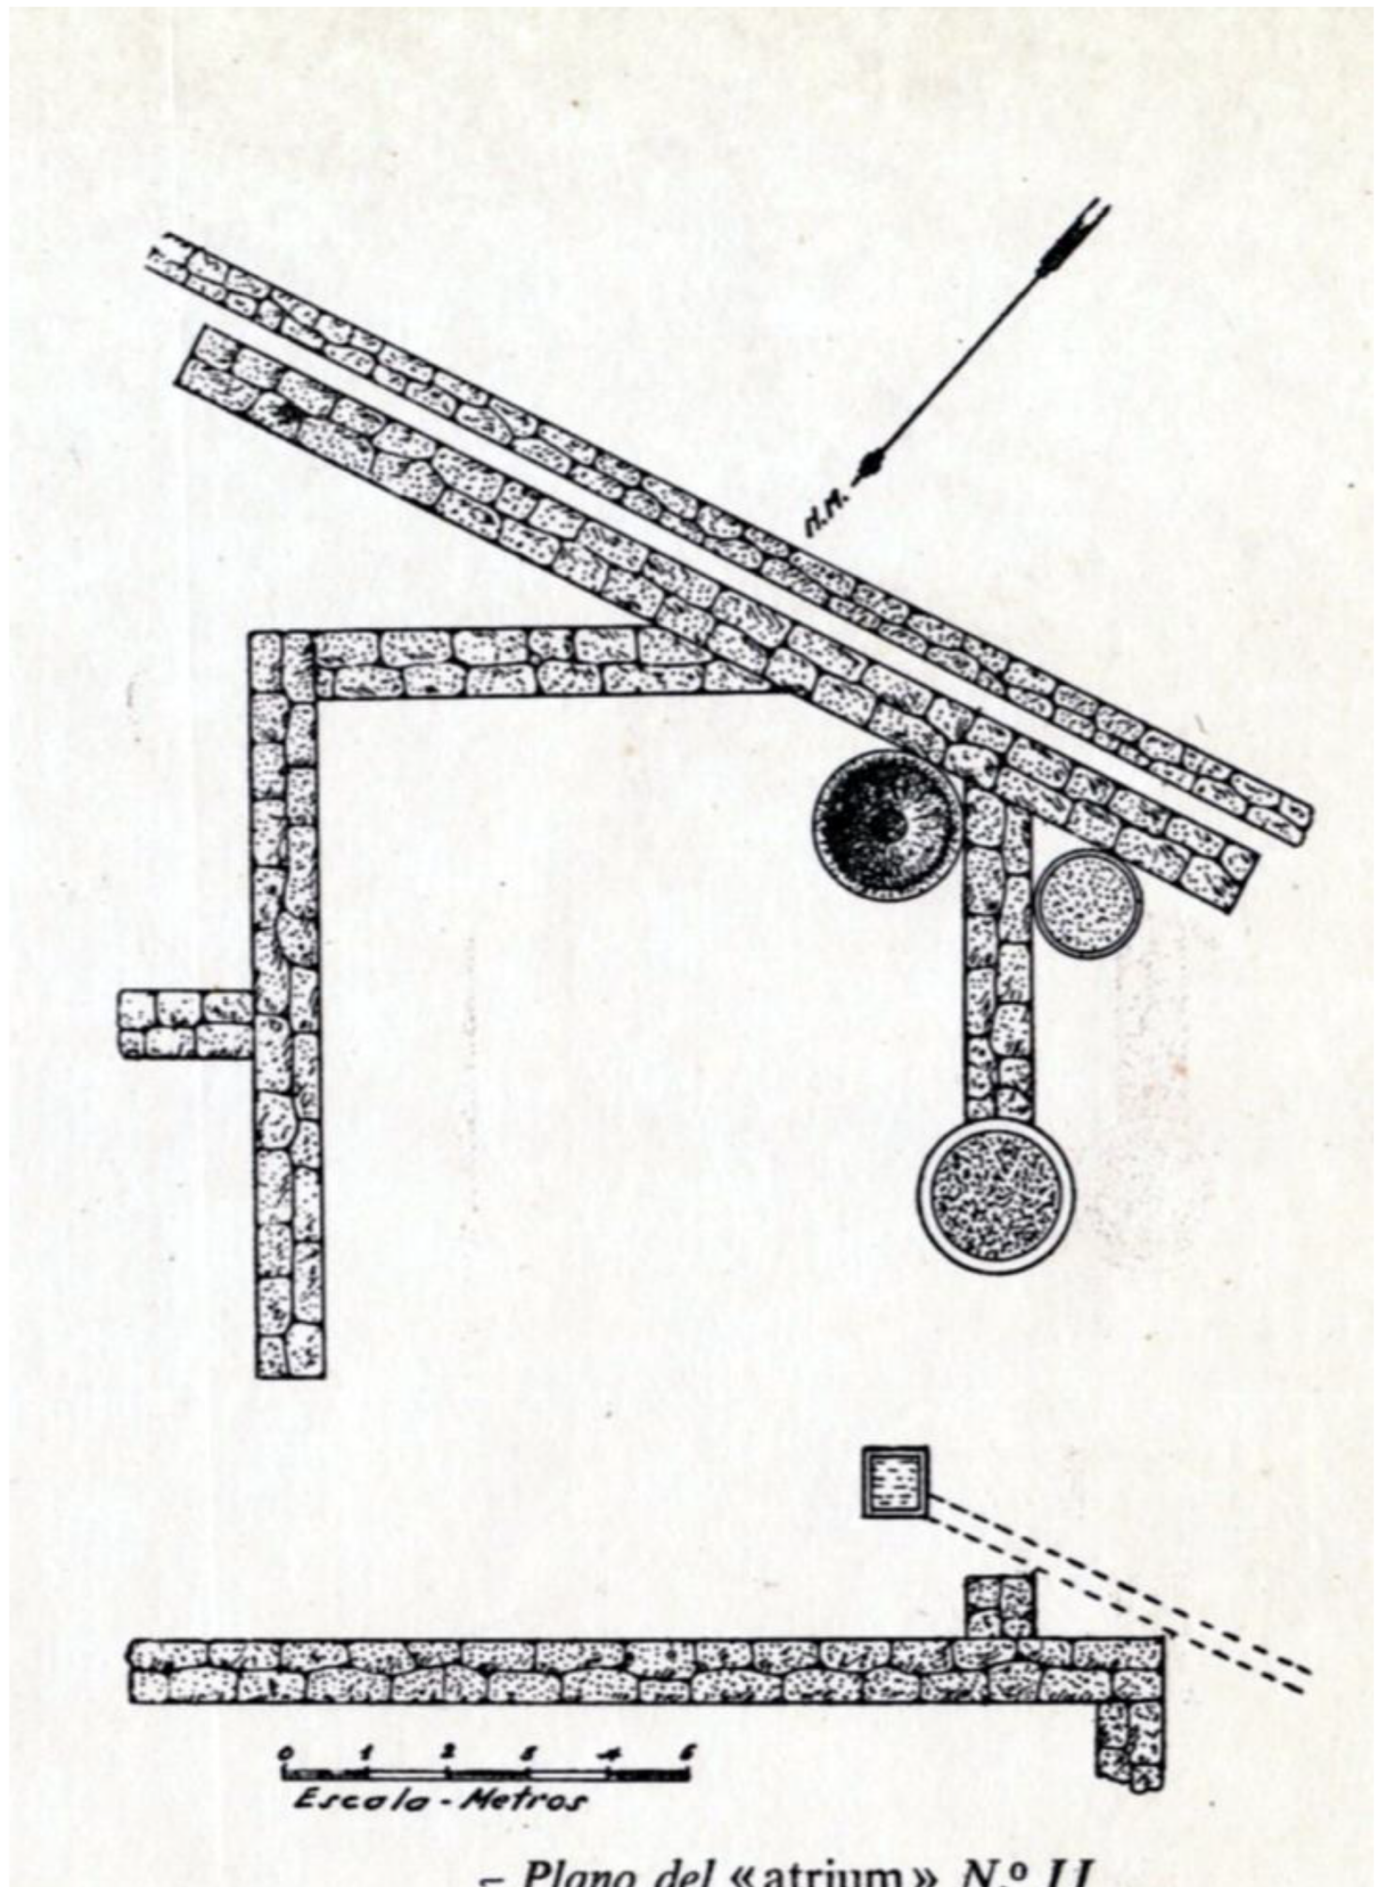
Figure 8. Plan drawn in 1955 ^[9] (Conde Valvís 1959: 486).

Conde-Valvís ^[9] (pp. 483–484) describes this courtyard as a floor paved by small, unevenly sized, stone slabs, with a channel running across it, from E to W, and a compluvium built with four stones, 0.12 m thick, forming a square deposit with 0.25 m sides (inner measurements). A staircase on the south side of the wall gave access to an upper storey. A small wall projects from the staircase towards the centre of the courtyard. It is 0.80 m long and 0.40 m thick, and it ends in a crudely carved granite block, which is approximately 0.50 m high (**Figure 8**). In his publication, Conde-Valvís, along with the general arrangement of the courtyard, describes different architectural elements found during his excavation, including the base of a column that probably sat on the granite block and a column shaft fragment which he placed on the base to take a photograph (**Figure 9**). He also describes a mortar found to the east of the small wall. Finally, he mentions a fragmentary millstone that sat vertically on the channel, acting as a water sluice. Like with the atrium in the house of the Hexasquel, the building was backfilled after the

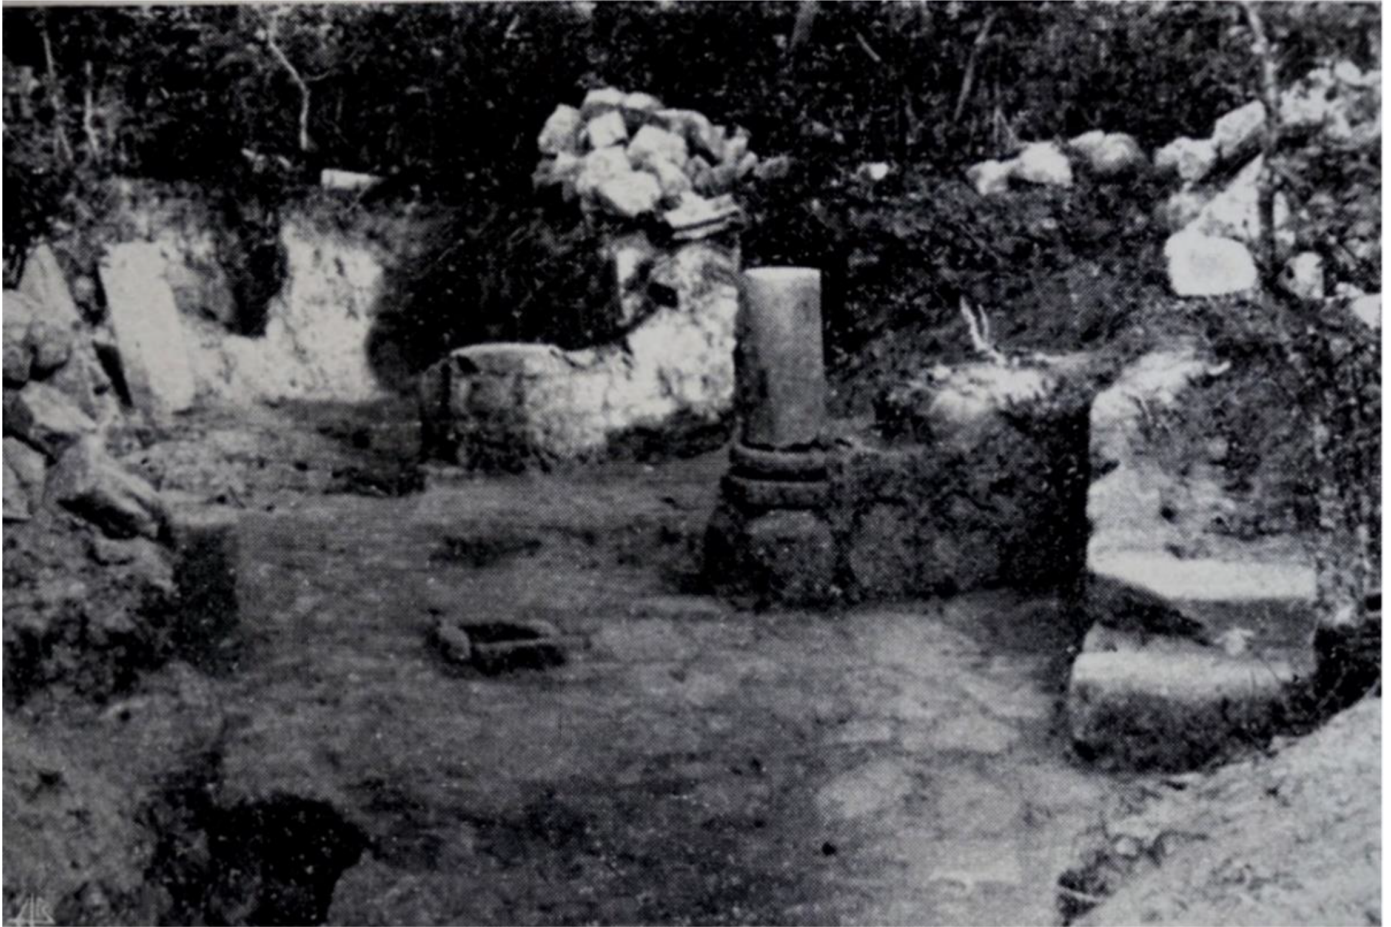
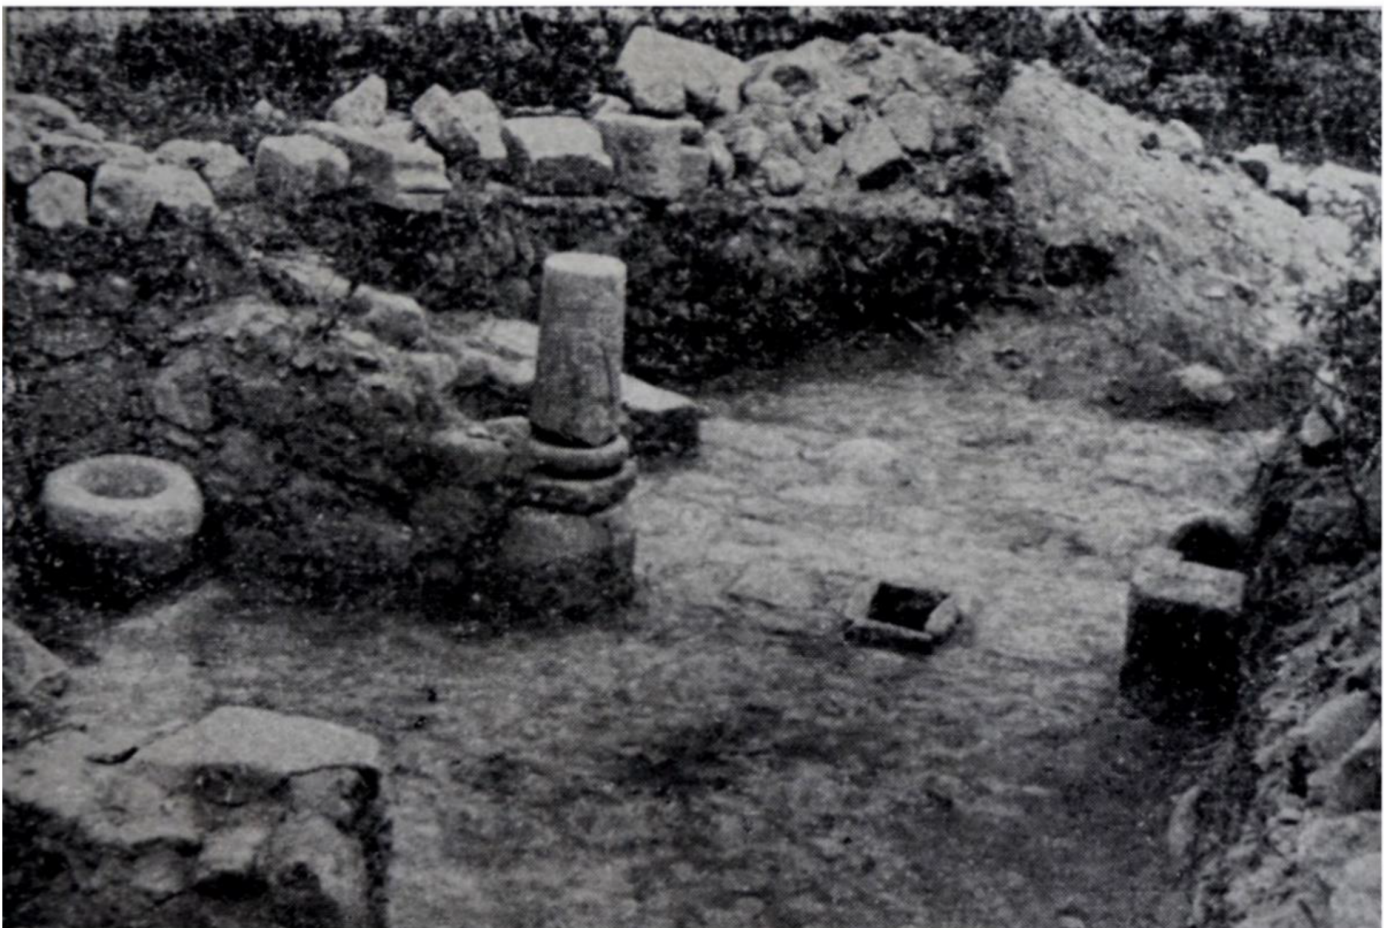
Figure 9. Several views of the courtyard of the Rosette after excavation ^[9] (Conde Valvís 1959: Plate II).

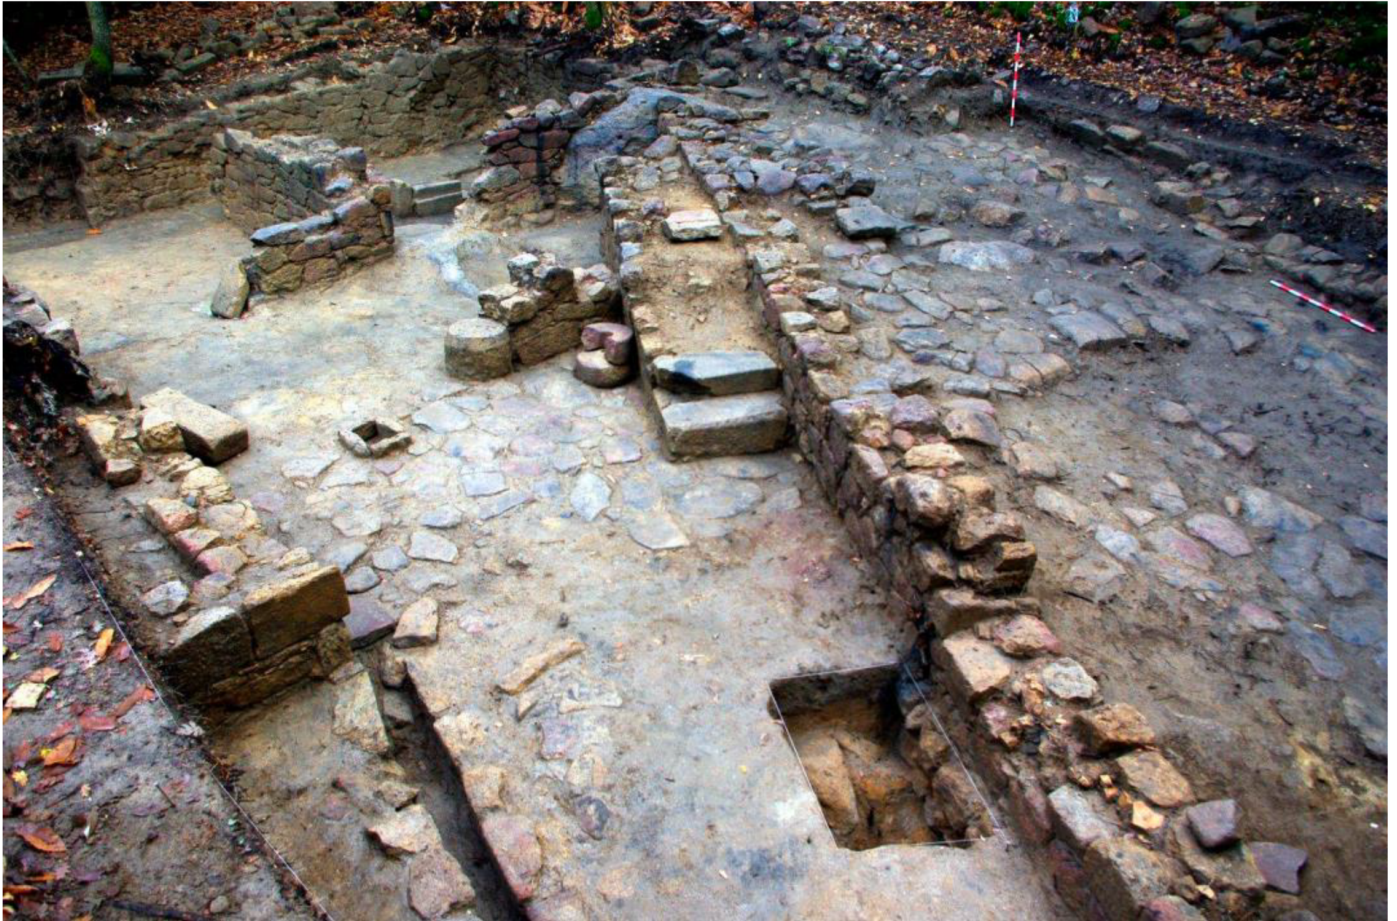
Figure 10. View of the atrium of the Domus of the Rosette after the 2011 excavations. Photograph: David Pérez.

Between 2011 and 2012, the City Council of Allariz resumed the excavation of this area; the excavation was directed by David Pérez. The loose objects described by Valvís could not be found, except for a few threshold stones that had been piled near the site (**Figure 10** and **Figure 11**). The crude granite base was found in situ, and a small column shaft found near the estate's perimeter wall was placed on top, in an attempt to recreate Valvís's old photographs ^[13] (p. 89).

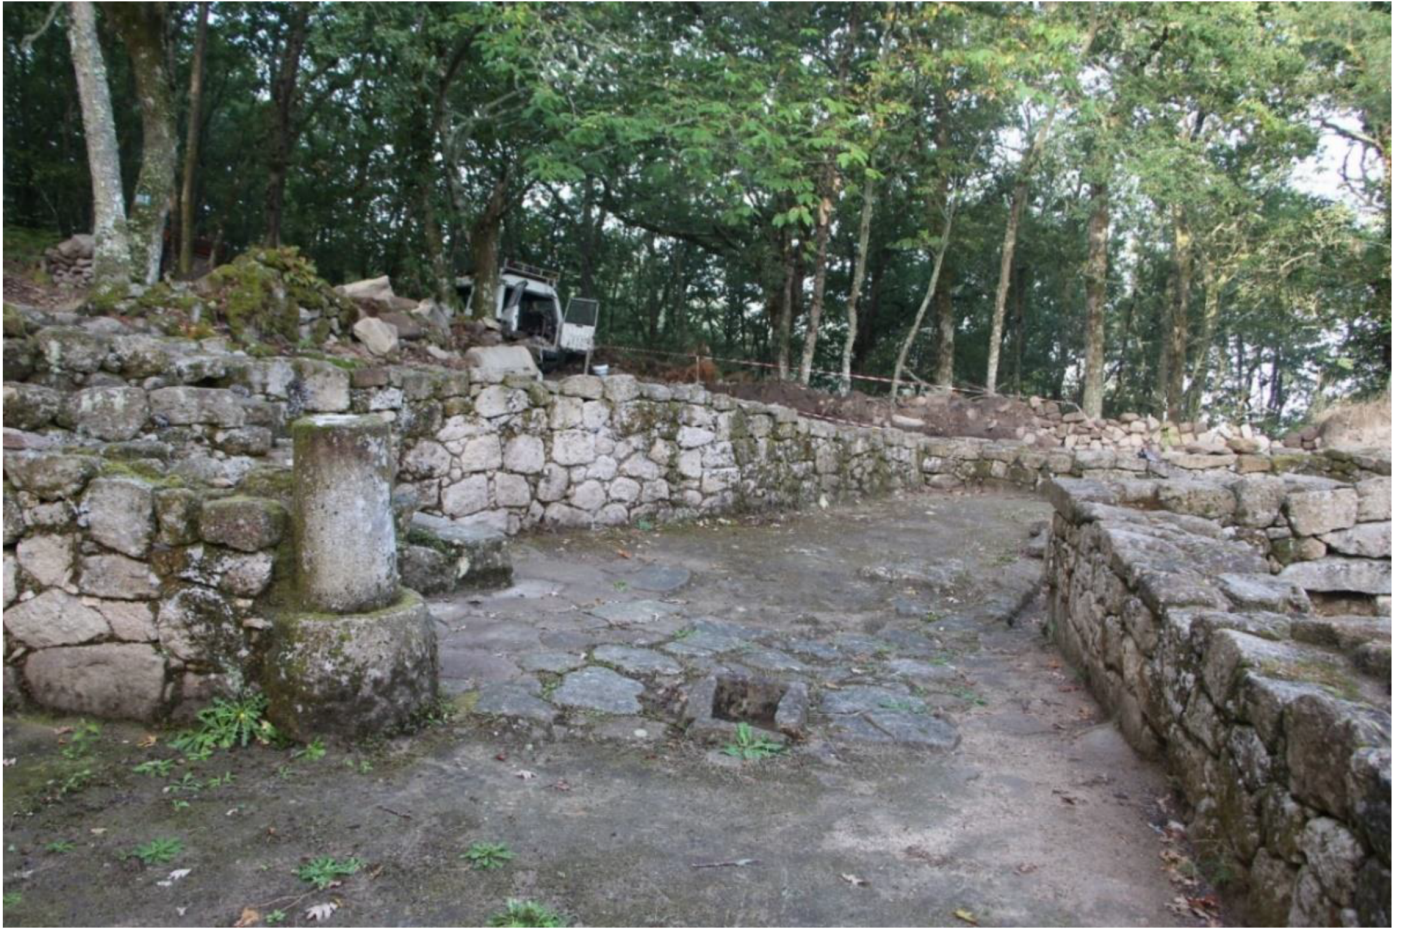
Figure 11. View of the site after the 2011 and 2012 works: Photograph: Council of Allariz.
