# Microbial Colonization of Stone

Colonization and deterioration of stone heritage buildings by microorganisms, especially cyanobacteria. Aesthetic, chemical and physical types of deterioration are covered. Future changes in climate will affect these processes. Seven figures illustrate various aspects and organisms involved.

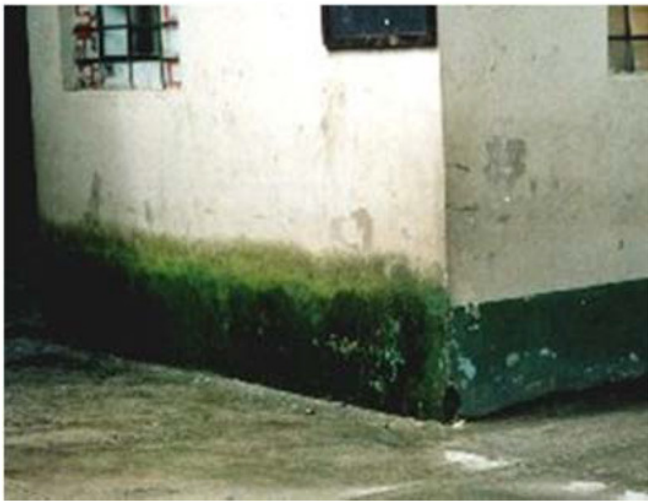
**Figure 1.** Heavy algal growth on the wet pediment of a building in Aguas Caliente, Peru.

Both algae and cyanobacteria can produce thick green biofilms in areas of high humidity (Figure 1), but in less wet areas the colors may vary, especially in the case of cyanobacteria (Figures 2 and 3).

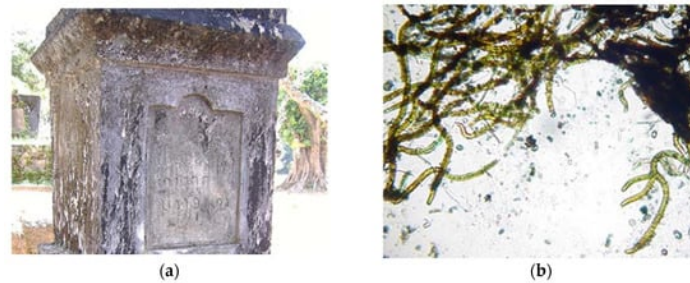
**Figure 2.** (a) Black discoloration on a gravestone in Dom Khom, Laos, (b) the green/brown cyanobacteria (genus *Scytonema*) mainly responsible.

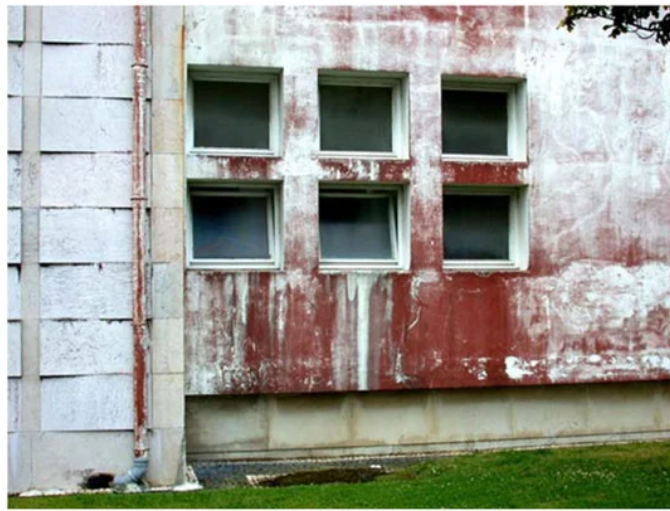
**Figure 4.** *Trentepohlia* algae forming deep red discoloration on the painted wall of a public building in Ponta Delgada, Azores, Portugal.

Not only cyanobacteria, but also some algae, can be responsible for non-green discolorations. An excellent example is the filamentous alga *Trentepohlia*. Although classified with the green algae, these cells are frequently identified when growing on external walls by their red coloration (Figure. 4), caused by carotene-containing oil droplets within the cells.

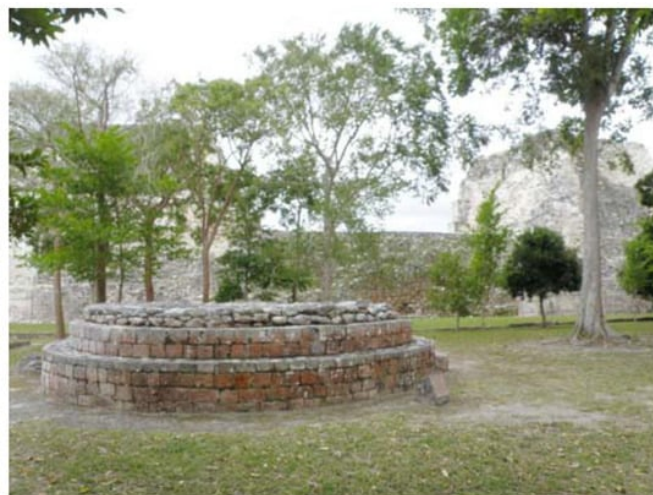
**Figure 5.** Stone altar in the architectural zone of Becan, Campeche state, Mexico, showing red staining (*Trentepohlia*) on North and East facing sides.

On the Rio Bec style Mayan buildings at Becán, Chicanná and Hormiguero (Campeche state, Mexico) it was found that red colorations caused by these algae were predominantly associated with North- and East-facing walls (Figure 5), or on otherwise orientated sites protected by tree canopies or architectural elements [19]. On more exposed sites, grey-black discoloration composed of dehydration- and UV-resistant cyanobacteria (the most common being the coccoid genera *Gloeocapsa* and *Chroococcidiopsis*) was dominant.
