# Wear Mechanism for Construction Machinery

Construction machinery, which is widely used in infrastructure construction, is growing rapidly all over the world. However, the complex working conditions of construction machinery lead to serious wear, particularly the wear of the bucket teeth on construction machinery. To control the wear procedure, it is essential to understand the wear mechanism and identify the wear form under variable working conditions.

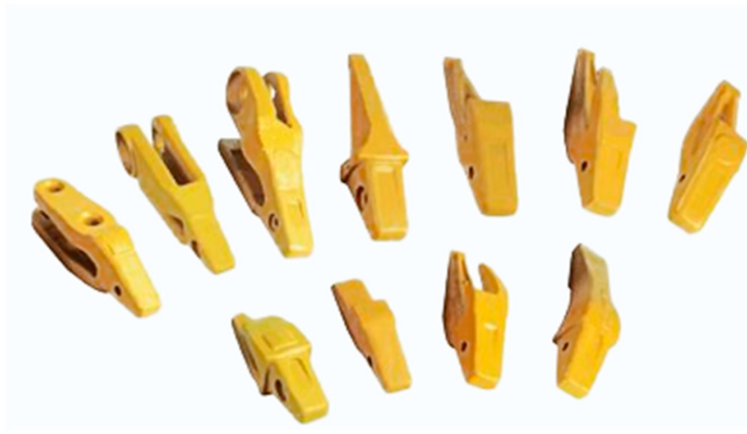
**Figure 2.** Different forms of bucket teeth.

The bucket teeth are a crucial component of the cantilever beam member in excavators. It comprises the shovel head, shovel seat, and ring clips, and its degree of wear and fracture directly affects the quality and efficiency of extraction. Bucket teeth come in different forms (**Figure 2**), including rock teeth, earth and rock square teeth, conical teeth, bucket teeth, and others <sup>[3]</sup>. The most common bucket tooth type is the conical tooth, located at the front of construction machinery, in direct contact with materials. This causes significant wear and varies in form. During excavation, the tip of the bucket teeth bear an impact load when inserted into materials, resulting in impact wear. As the bucket teeth deepen, the material above increases, causing relative sliding and two-body abrasive wear on the bucket teeth. As the bucket teeth deepen, materials roll along their surfaces into the bucket. The fine material's gravity is negligible, and pressure on the bucket teeth is minimal, causing three-body abrasive wear <sup>[4]</sup>. The unloading of the excavator and loader bucket also experience three-body abrasive wear. Fretting wear has complex sources, including environmental vibrations and alternating stresses.

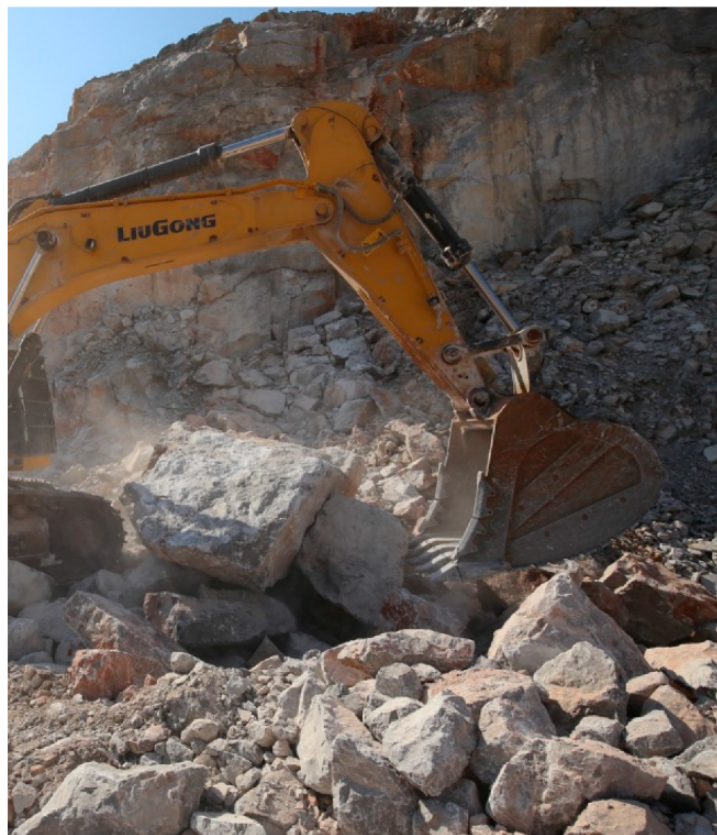
**Figure 3.** Working conditions with impact wear governed.

Impact wear <sup>[5]</sup> is a unique type of wear that is often observed in engineering, resulting from a combination of processes such as impact and sliding friction wear. This wear type occurs on the surface of the part that keeps the abrasive material crumbling. In impact wear, concentrated compressive stress is present at the abrasive contact, the plastic rheology, and fatigue of the ductile phase on the metal surface, while the hard phase is fractured. This indicates that the stress on the material has exceeded the crushing strength of the abrasive, making it high-stress wear <sup>[6]</sup>. When inserted and excavated into a mine, bucket teeth are subjected to strong impact loads, resulting in chiseled abrasive wear. The abrasive rock grains move rapidly on the metal surface of the bucket teeth, with their sharp edges resembling knives cutting the tooth surface. This action causes plastic deformation and forms plastic change grooves. The magnitude of the cutting resistance is determined by factors such as the nature and state of the ore rock, the geometry of the cutting part, the cutting angle, and the cutting thickness <sup>[7]</sup>. **Figure 3** illustrates the working environment of construction machinery engaged in excavating materials under conditions of impact wear.

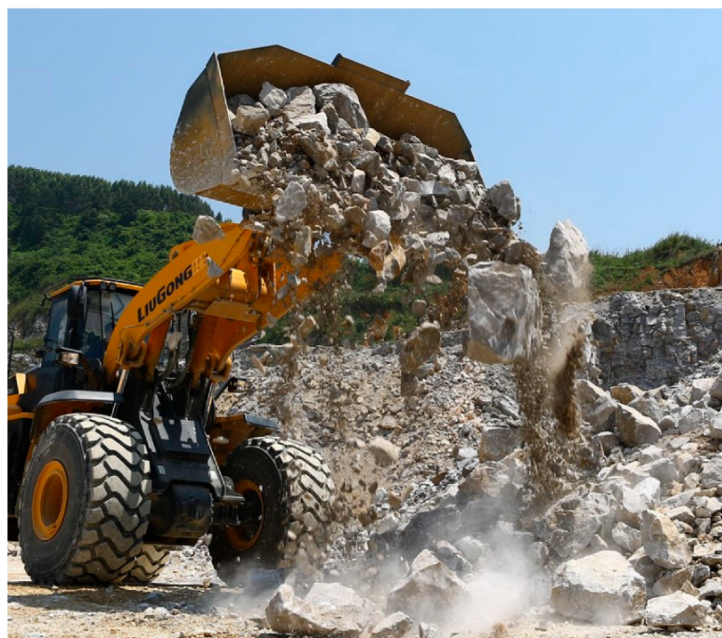
**Figure 4.** Working conditions with abrasive wear governed.

Typically, the bucket scoops from the bottom upwards, and the bucket teeth slowly penetrate the material, resulting in relative sliding between the two. The weight of the material exerts pressure on the bucket teeth, causing sliding friction wear, which is a type of two-body abrasive wear. When discharging, the bucket is tilted downward, and the material rolls out of the bucket (**Figure 4**). At this point, there is minimal contact between the material and the bucket teeth, resulting in rolling friction wear, which is a type of three-body abrasive wear.
