Failures of the Photovoltaic Module Components

1. Introduction

2. Failures of the PV Module Components: Discussion and Observations

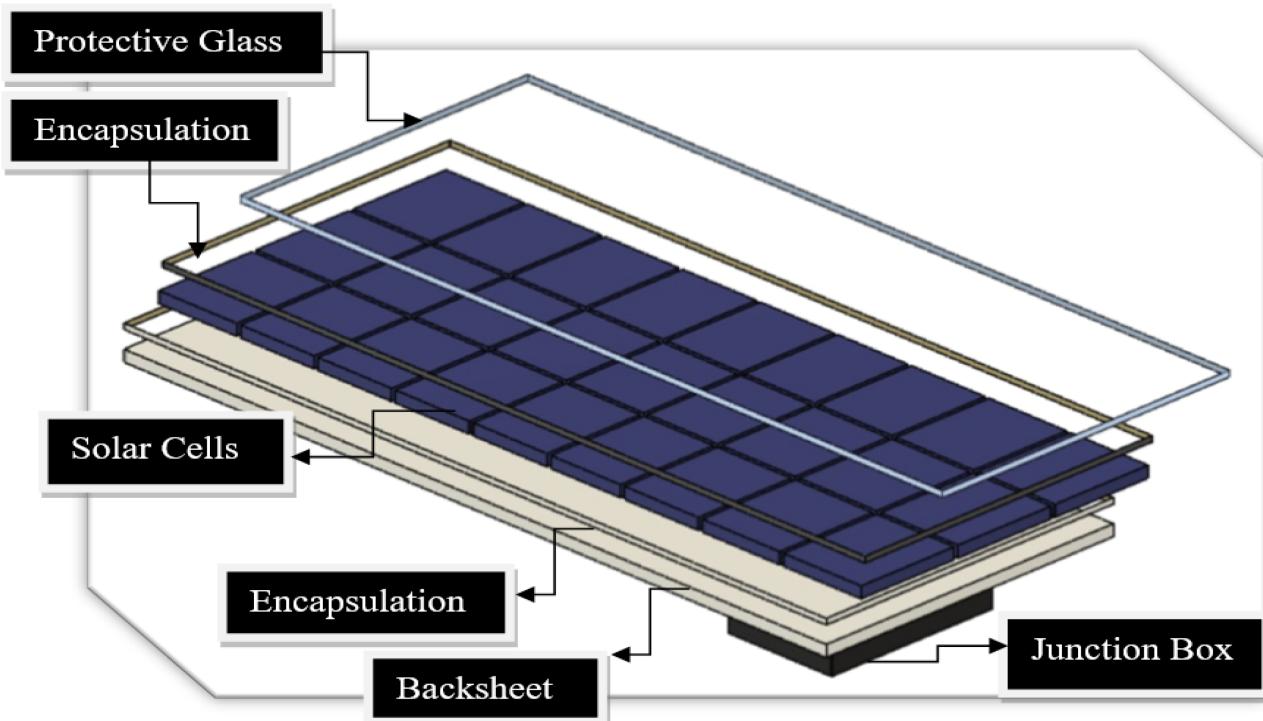
A PV module consists of solar cells, solder, an encapsulant, protective glass, and a backsheet, see **Figure 1**. The most common raw material for the PV cell is silicon. Although silicon is not the ideal element for power conversion efficiency, its properties have been extensively studied and well understood by the market before the development of solar cells [4][19].

Figure 1. PV module components designed using Fusion 360 software. (The software is from Autodesk and is called Fusion 360. The version is 2.0 and Autodesk are located in San Francisco, CA, USA).
