Inspection of Wind Turbine Blades

2. Inspection of Wind Turbine Blades

3. Manufacturing, Load Types, Damages, and Standards of Wind Turbine Blade

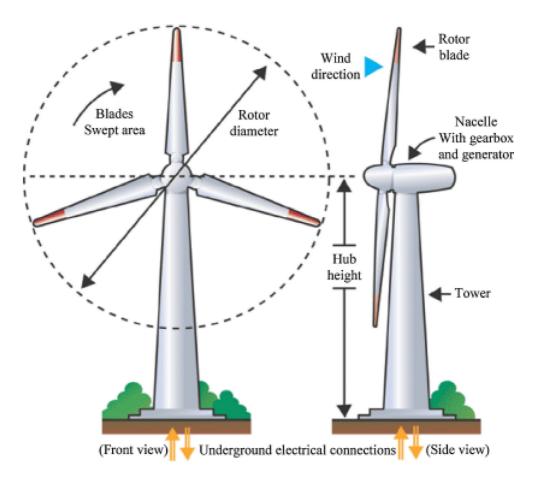
The wind is harvested through wind turbines, which generate electricity by rotating the blades attached to the rotor, which is attached to the nacelle at the top of the tower, as shown in **Figure 1**.

Figure 1. Wind turbine: front view and side view [14].

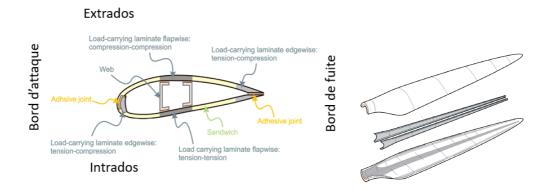
A wind turbine blade is made of two parts, the lower and upper surface, which are connected and stiffened with one or more shear webs that connect the upper and lower parts of the blade shell ^[15], as shown in **Figure 2**. This figure illustrates the cross-section of a WTB: the leading edge, the trailing edge, and the lower and upper surface.

Figure 2. Design diagram of a wind turbine blade adapted [16].

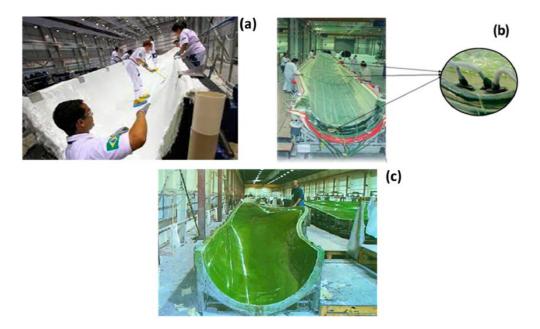
Wind turbine blades are manufactured with composites using a process that is still very manual, leading to different types of defects. Hence, non-destructive testing is required to provide information on the surface and sub-surface of the blade while demonstrating the ability to inspect the blade from the surface ^[18]. Early types of WTBs were manufactured by wet hand lay-up technology (**Figure 3**a). Fiberglass was impregnated with rollers and brushes. After being joined by adhesive, the shells are connected to the stringers. The cloths for the larger blades are sandwiched using the same approach but with a higher plies' fiber content. As shown in **Figure 3**b, product quality improved with vacuum infusion and the prepreg approach. The prepreg technology was developed by aerospace productions, using impregnated composite fibers. Resin infusion technology was adopted for large turbine blades by positioning the fibers in a closed mold; then, the resin is pumped into the mold. Heat is also applied for curing as soon as the resin settles on the fibers. This technique can be classified as resin transfer molding and vacuum-assisted transfer molding (**Figure 3**c) ^[19].

Figure 3. Manufacturing processes of a wind turbine blade (**a**) hand lay-up, (**b**) vacuum infusion or prepregging, (**c**) vacuum-assisted resin transfer molding (VARTM) ^[19].

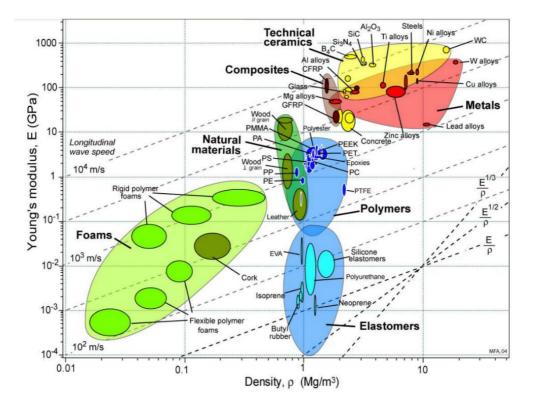
Various materials are used to manufacture WTBs, but the applicability of these materials depends on their weight and stiffness. As shown in **Figure 4**, composite fibers have adequate strength and stiffness. Despite their high strength and stiffness, composites are lightweight in essence. The fiber orientation in a laminate governs the characteristic behavior of the composite. Therefore, composite materials are usually the preferred choice of material for the manufacturing of WTBs ^[19]. Furthermore, experimental studies demonstrate that a low temperature increases the stiffness and compressive strength of CF/CPTSP. Conversely, higher temperatures may cause diminishing mechanical properties in composites ^[20].

Figure 4. Wind turbine blade materials [17].

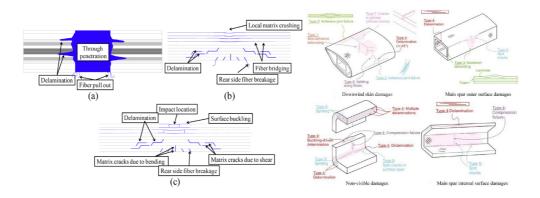
As explained earlier, a good understanding of the causes of deterioration of composite WTBs is crucial to the life of the blades. This is of great significance, since the blades are subjected to different loadings. Defects in composite materials ending in the deterioration of composites have been extensively studied. **Figure 5** presents significant information on the different deterioration mechanisms resulting from the action of loads.

Figure 5. Different types of defects. Deterioration mechanisms caused by impact loading (**a**) higher, (**b**) medium and (**c**) lower ^[19].

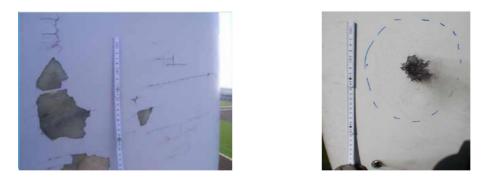
Figure 7. (a) Cracks and peeling in gelcoat ^[30], (b) Damage caused by lightning ^[30], (c) Evolution of leading-edge erosion by normal wear ^[31].

- Cracks: Breakage of the laminate or glue joint. Even if it seems harmless, a crack should never be overlooked, since it may be larger in size and may propagate (**Figure 7**). Mmechanical fasteners (such as clips, screws, etc.) can be used to join composites or mixed materials, but they require additional steps to mold or create features for the fastener. These additional features eventuate in stress concentrations and non-uniform stress distribution, which can result in cracking and failure;

- Cracking: Grouping of several cracks located at the root of the blade and along the leading edge and surfaces, opposite the spars;
- Microcracks: Cracks (or spalling Figure 6 and Figure 7) are often thinner than the gelcoat caused by poor infusion at the factory. They are difficult to detect, and their observation depends on the inspector's perception. In the case of hardening as a consequence of microcracking, the relative displacement of the microcrack faces over loading and unloading cycles causes them to grow;

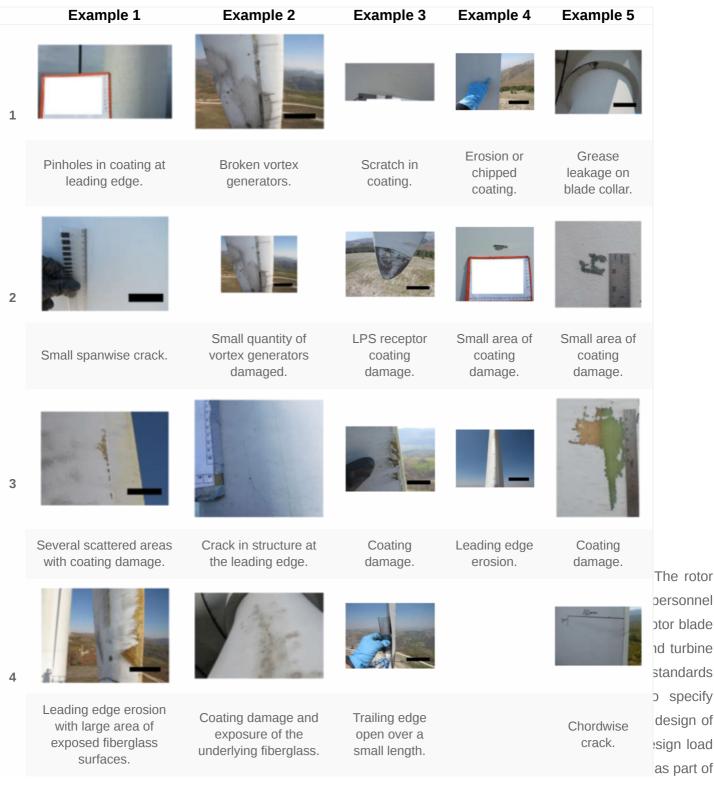
cause for concern and re-evaluation. **Table 1** depicts photographic examples of damage and defects in each category.

Table 1. Photographic examples of damage and defects in each category [32].

Example 1	Example 2	Example 3	Example 4	Example 5	for wind
						and rotor
						reinforced
						art of the
5						fication of
	Trailing edge open over a significant length.	Long leading edge chordwise crack with spanwise cracking.	Iral and functional design and manufacturing of rotor blades			
			testing, repair, a	nd operation ^[33] .
