# Defect Types and Mechanism of Wind Turbine Blades

Contributor: Wenjie Wang , Yu Xue , Chengkuan He , Yongnian Zhao

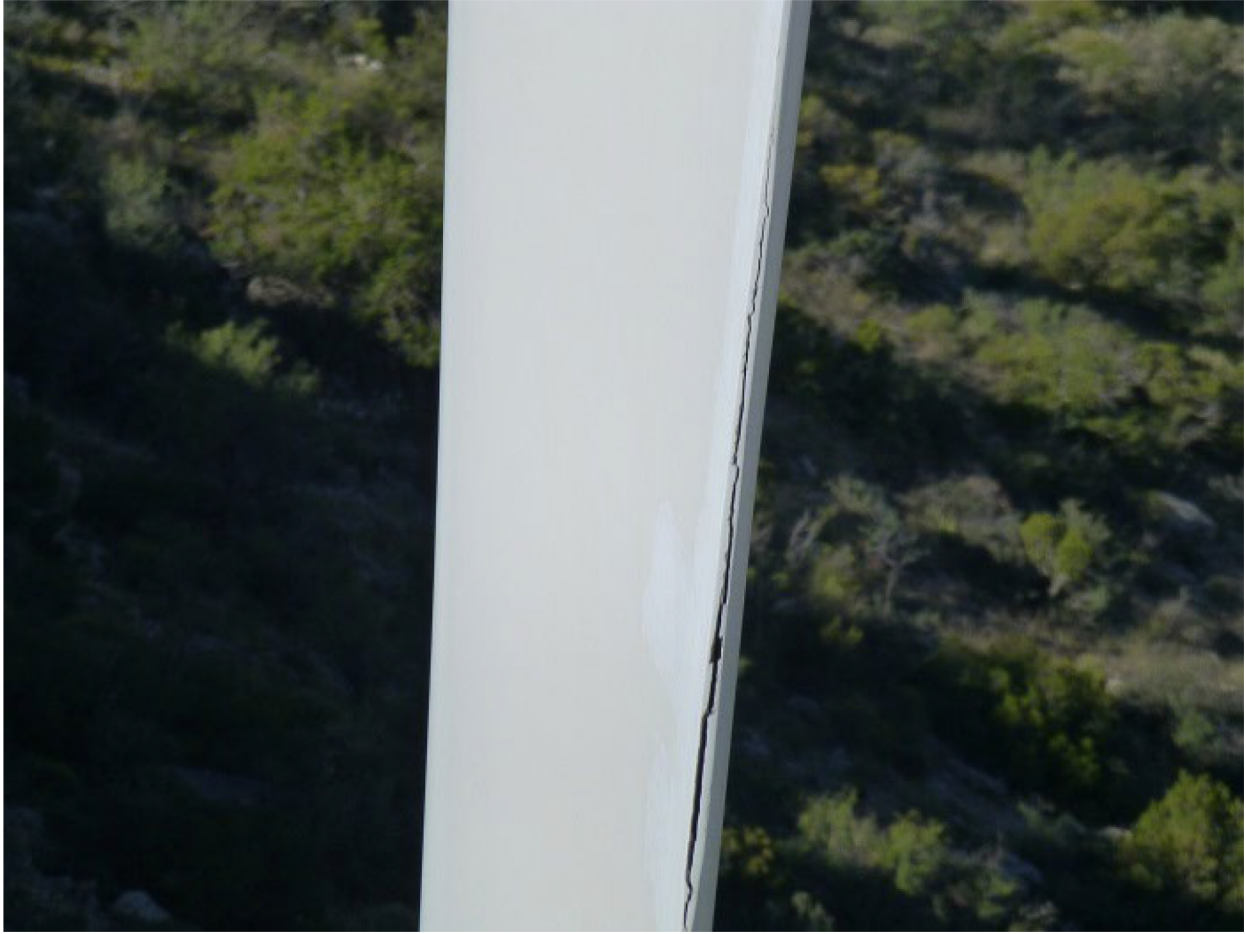
**Figure 1.** Longitudinal cracks found on the trailing edge of a wind turbine blade.

The main manufacturing materials of wind turbine blades are glass fiber-reinforced polymer (GFRP) and carbon fiber-reinforced polymer (CFRP). The two half shells of the blade, which are made of these two materials, are bonded to form a complete blade. The trailing edge of the wind turbine blade is the area where the two half shells are bonded. There are many damage modes in this area, and cracking is the main damage mode, which is mainly divided into a longitudinal crack and transverse crack. The longitudinal crack at the trailing edge refers to the crack consistent with the length direction of the blade <sup>[1]</sup>, as shown in **Figure 1**. Such cracks mainly occur at the root and tip of the blade. The longitudinal crack at the trailing edge of the tip is mainly due to a reduction in the thickness of the shell, resulting in a reduction in the stiffness of the blade. This low stiffness leads to increased blade loading, resulting in higher shear stress on the shell and bonding material at the tip. This may be a major cause of the cracking at the tip of the trailing edge, while the longitudinal crack at the root trailing edge may be mainly due to the high stress caused by the geometric changes and fatigue load in these areas <sup>[2][3]</sup>.

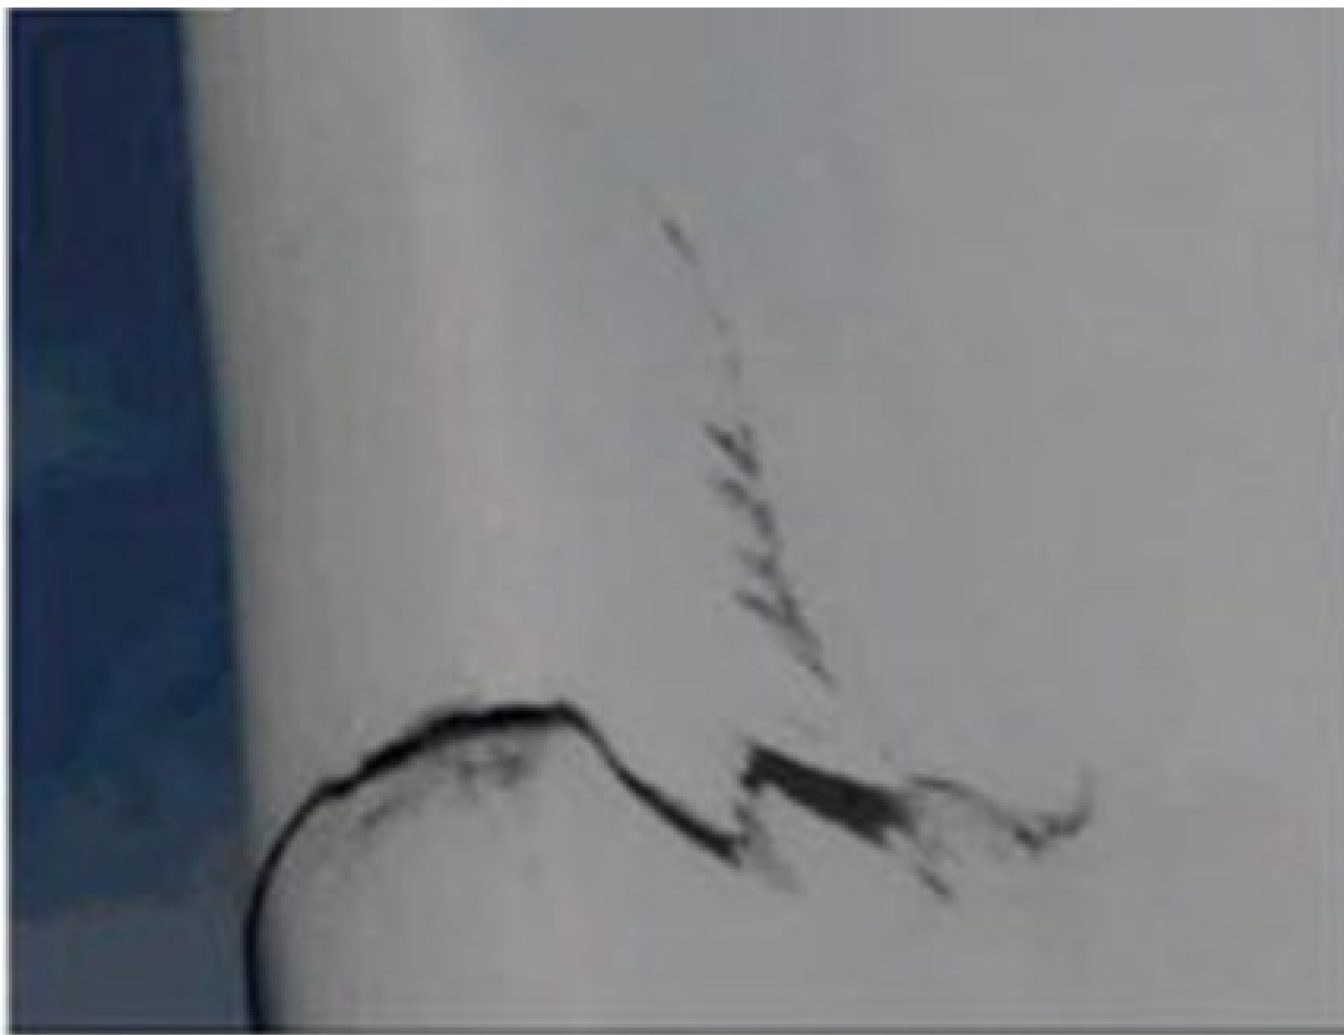
**Figure 2.** Transverse cracks found on the trailing edge of a wind turbine blade.

The transverse crack at the trailing edge is a crack perpendicular to the length of the blade, as shown in **Figure 2**. Some of these simple transverse cracks are only on one side of the blade. It may be due to the fact that one side of the blade needs to be polished in order to eliminate the asymmetry between the two shells of the blade during the manufacturing process, which leads to a reduction in glass fiber on one side, and this kind of crack occurs under the high load or stall of the blade. There is also a transverse crack that runs through the shell of the trailing edge of the blade in two measurements. This crack may have slowly penetrated the other side of the blade from the initial side. It is also due to the high load in this area. Such a crack is relatively dangerous because it completely cuts off the high load area of the trailing edge <sup>[4]</sup>.

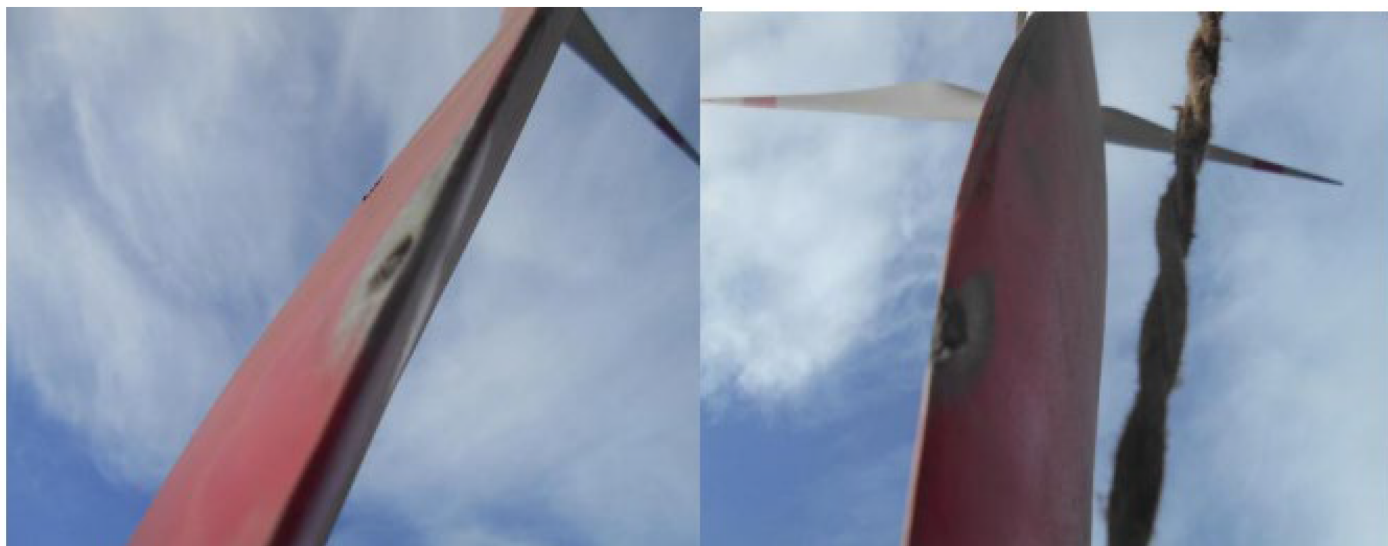
**Figure 3.** Holes in wind turbine blades caused by lightning strikes.

Although there is already an IEC61400-24 lightning protection standard for wind turbine systems, wind turbines with lightning protection systems are still subject to lightning strikes. The damage caused by lightning to the blades depends to a great extent on the material of the blades. Studies have shown that the use of carbon fiber-reinforced polymer (CFRP) for wind turbine blades makes them highly sensitive to lightning [5][6][7]. Most onshore wind farms are built on relatively remote, high ridges, which are rich in wind resources but also increase the risk of lightning strikes on wind turbines; this is because higher ridges are mostly made up of rocks or soils with high electrical resistance [8]. The current lightning protection system for wind turbines uses top metal receptors to momentarily introduce strong currents underground. Soils with high resistance on ridges, on the other hand, can make it impossible for large impulse voltages to rush into the ground, which will cause blade damage. More than 88% of the lightning attachments occur within 1 m of the outermost tip, as shown in **Figure 3**.

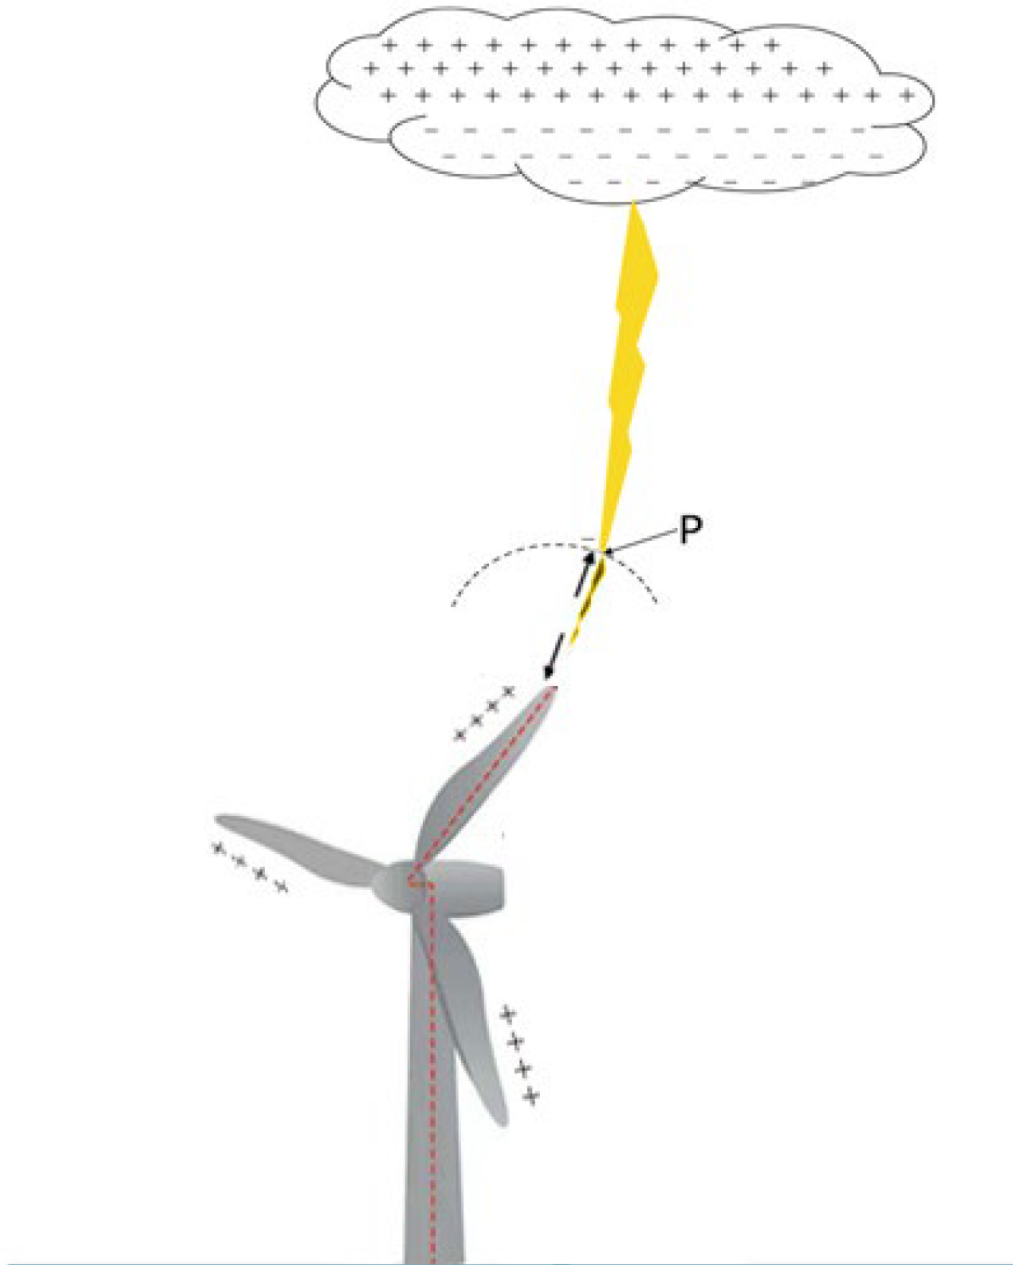
**Figure 4.** Lead development process diagram for when lightning strikes wind turbine blades.

The essence of lightning is caused by the breakdown of a medium of air between a cloud and the ground or between a cloud and a cloud. The negative charge accumulated at the bottom of a thunderstorm cloud forms a strong electric field with the positive charge generated by the ground. As the charge of a thunderstorm cloud accumulates, it discharges to the ground and travels along the air [\[9\]](#)[\[10\]](#). When the tip of the discharge reaches a certain distance from the wind turbine blade, a strong electric field is induced with the metal acceptor of the lightning protection system installed in the blade, as shown in Point P in **Figure 4**. When the air at this distance reaches the breakdown threshold, the blades will also emit leads in an attempt to capture the tip of the discharge. Charge neutralization occurs in a short time and forms a circuit that forms lightning. Great thermal shock from lightning-induced arcs will cause blade damage [\[11\]](#)[\[12\]](#). Contaminated areas on the surface of blades made of GFRP composite materials (e.g., humidity, dirt, salt, insects, etc.) can also become receptors under a sufficient electric field [\[8\]](#)[\[12\]](#).

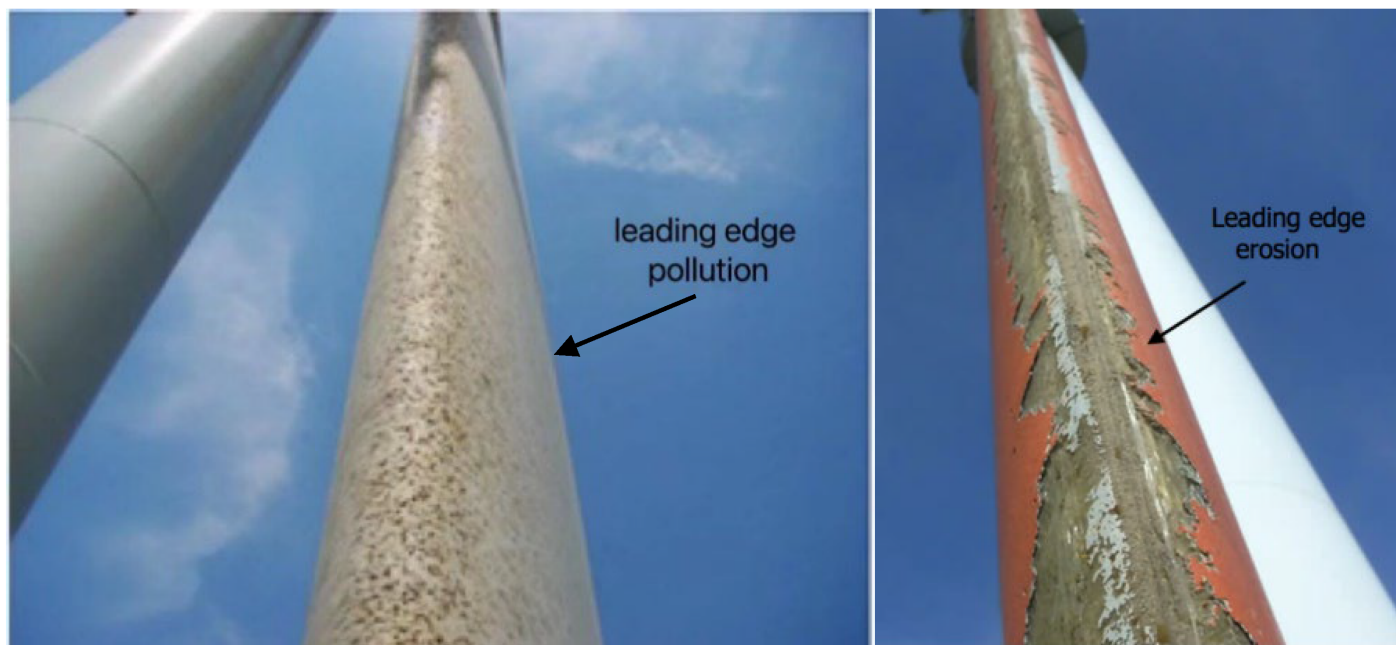
**Figure 5.** Corrosion pollution of a wind turbine blade's leading edge.

Corrosion and contamination at the leading edge of wind turbine blades is one of the key problems in wind power production, as shown in **Figure 5**. Erosion and contamination at the leading edge of the blade results in an increase in the resistance coefficient and a corresponding decrease in lift coefficient, which reduce the generation of electricity. Studies have shown that corrosion contamination on the leading edge of blades can reduce the annual energy production (AEP) by 2% to 3.7% [13]. Severely eroded blades result in AEP up to 25% [14]. The AEP of heavily contaminated blades is reduced by 10–13% [15]. Noise is also generated. The degree of corrosion and contamination of wind turbine blades depends on environmental conditions such as temperature, humidity,

Front edge corrosion contamination is a complex process. The main reason is that raindrops, hail, sand particles, etc., repeatedly hit the leading edge of blades, together with environmental conditions such as insects, dust, salt (corrosion of salt mist of offshore blower), and so on. Large droplets of rain hit the leading edge of the blade and generate pressure waves on the surface. These pressure waves propagate in the material of the blade and begin to cause fatigue, cracking, and surface roughening of the blade surface. As the density of the pit increases, a groove will eventually form [\[17\]\[18\]](#). Other large and hard particulates, such as hail and gravel, have high kinetic energy when impacting the leading edge of the blade. Especially in areas close to the tip of the blade where the speed is very fast, the erosion of the blade surface is a direct result. In severe cases, delamination and cracking will occur, which will reduce the structural stability of the blades. Blade contamination caused by insects occurs mainly in areas with low humidity and wind speed and temperatures of 10 degrees Celsius or higher because these are favorable conditions for insect survival [\[16\]](#). Additionally, chemicals such as salts and acids in rain or sea air will accelerate the corrosion of the blades, because they can interact chemically with the coating material [\[17\]\[19\]](#).

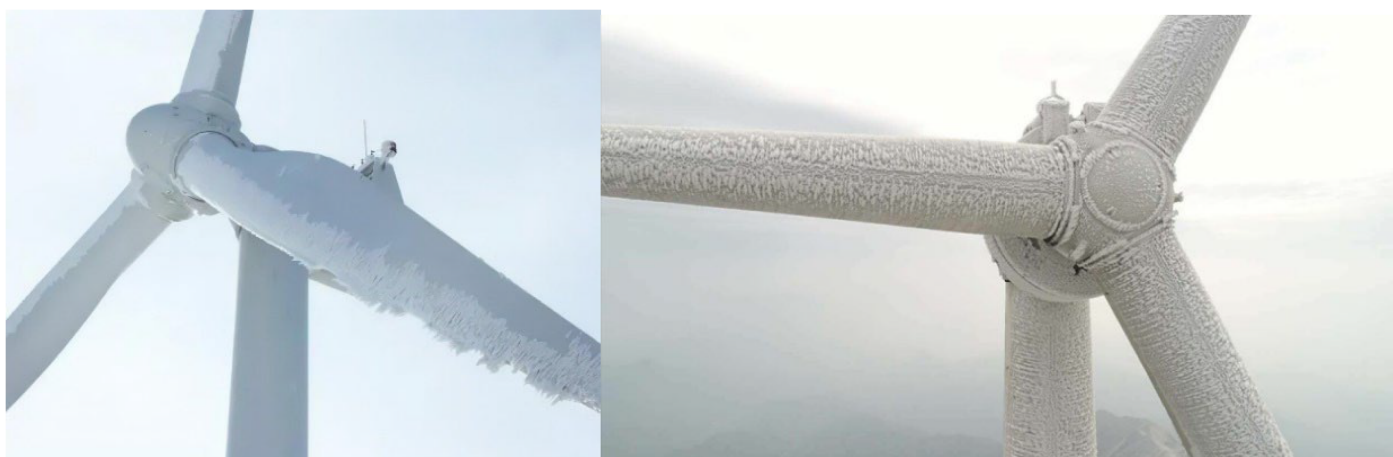
**Figure 6.** Ice on wind turbine blades.

The icing on wind turbine blades depends on temperature, humidity, air density, wind speed, and other variables. Ice characteristics are influenced by different parameters in ISO 12494, 2001 [22]. Different environments produce different ice types. The most common type of icing on wind turbine blades is frost, which is dense and very brittle. Because of the velocity of the incident. This ice first appears at the leading edge of the blade and then gradually covers the rest of the blade, as shown in **Figure 6**. Twenty percent of wind farms are located at high altitudes, where populations are scarce but there are abundant wind resources [23]; however, these areas have very strong wind and high cold air density, which poses a great challenge to the anti-icing and de-icing of wind turbine blades [24].

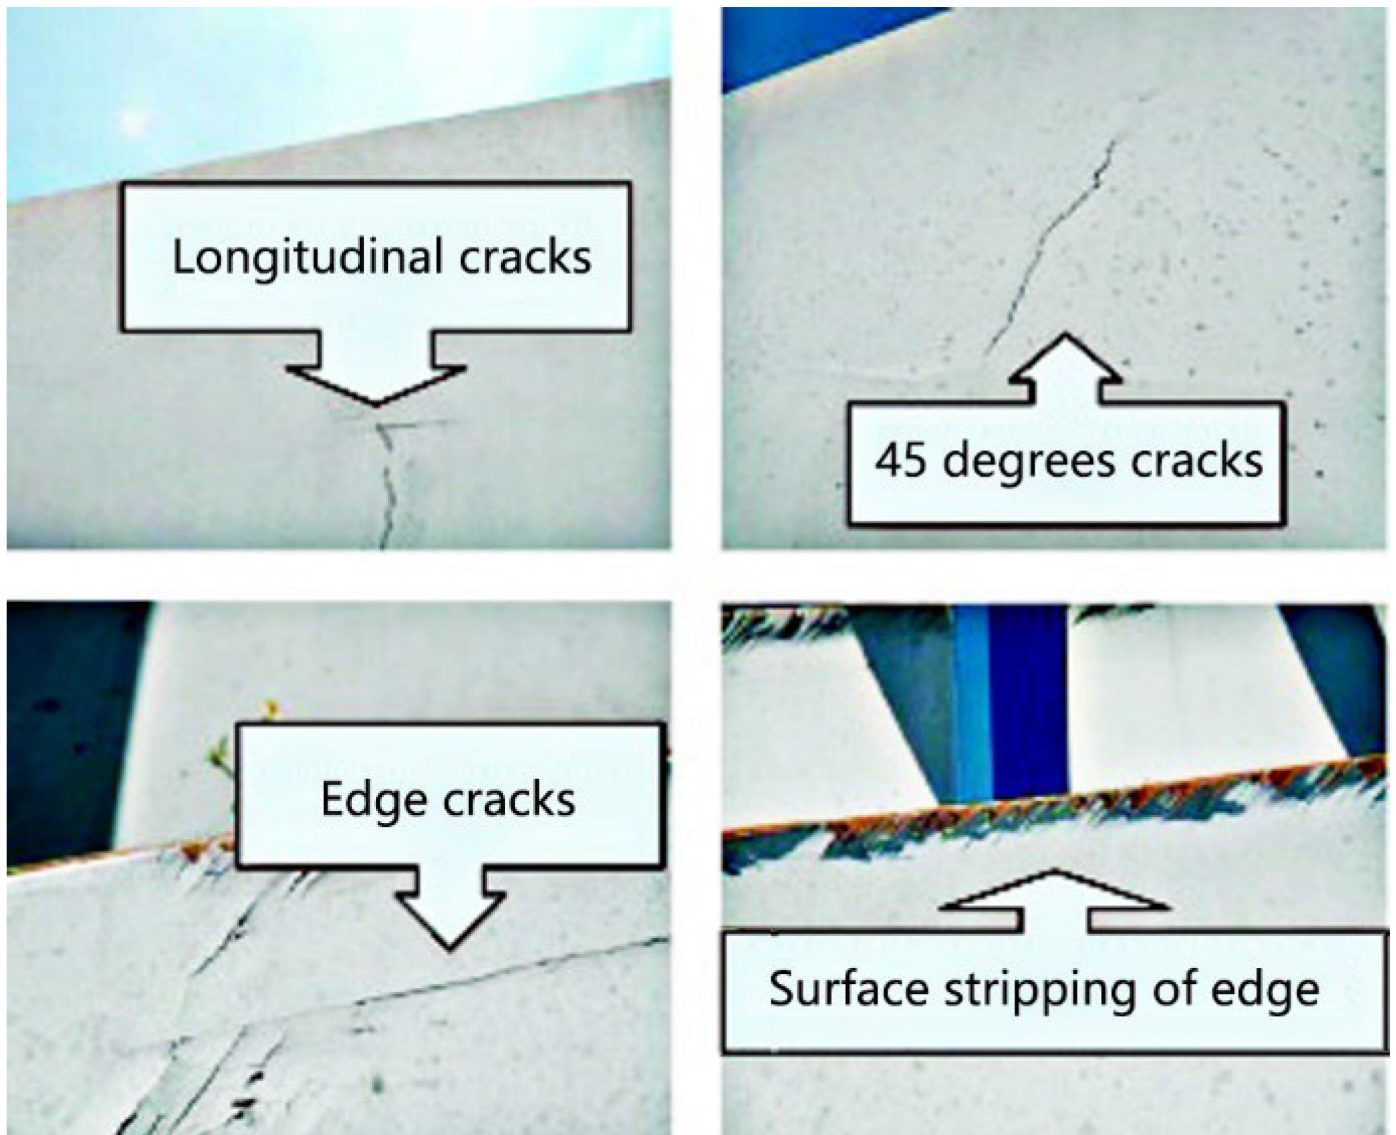
Figure 8. Different types of cracks.

With the increasing service time of wind turbines, the surface of wind turbine blades will gradually show slight cracks. These cracks usually expand with the service time of the wind turbine and the load of the wind turbine. If it is serious, it will lead to the fracture of the blade. Generally, a strong wind will make the blade bear complex and changeable high-strength loads, resulting in cracks and damage from the root, surface, and trailing edge of the blade, as shown in **Figure 8**. Therefore, the complex and changeable load is a direct factor affecting the service life of wind turbines.
