Hot Corrosion in Gas Turbine Blades

2. Hot Corrosion in Gas Turbine Blades

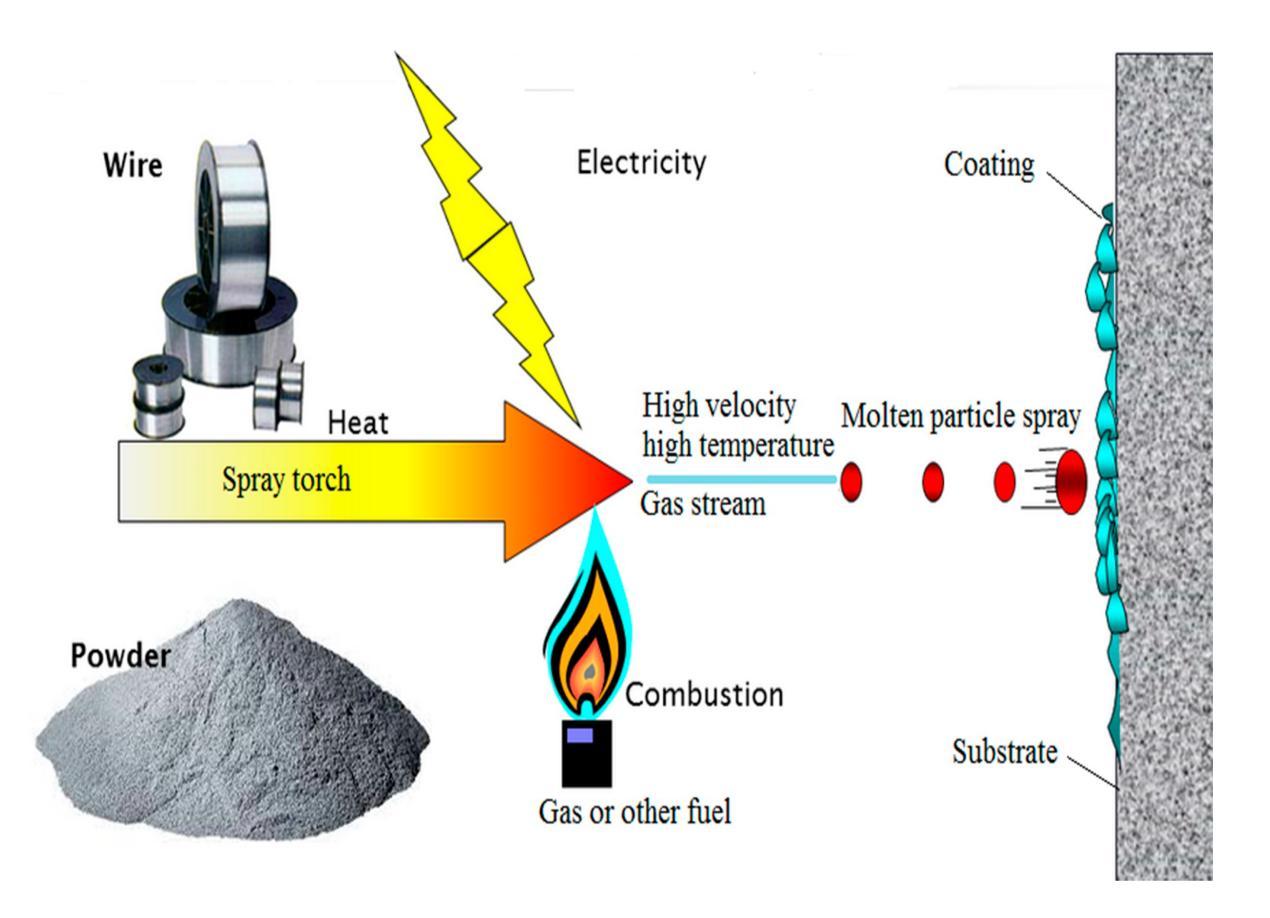
Figure 1. Thermal spray process. Modified with permission from ^[6]. 2007, Sudhangshu Bose.

Thermal spray is a coating process by which the fine particles of a material in metal or non-metal form are deposited on the surface of a formulated substrate in a molten or semi-molten state ^[1]. The material to be coated can be deposited in various states, particularly wire, powders, rods, suspension, or molten form ^[2]. The torch converts particles depending on the energy supplied into a hot gas stream. For combustion, chemical energy is used, and electric power is used for plasma generation ^[3]. The coating material heated during combustion or plasma generation converts to a molten state and is propelled by the high velocity and high-temperature gas stream to the substrate. The particles distort when depositing the substrate's surface to produce a splat. When new particles reach the surface, they combine to make multiple splat layers to complete the coating ^[4]. **Figure 1** shows the thermal spray coating process. While selecting a coating material, it should be kept in mind that the thermal expansion coefficient of the substrate and the coating material must match each other ^[5].

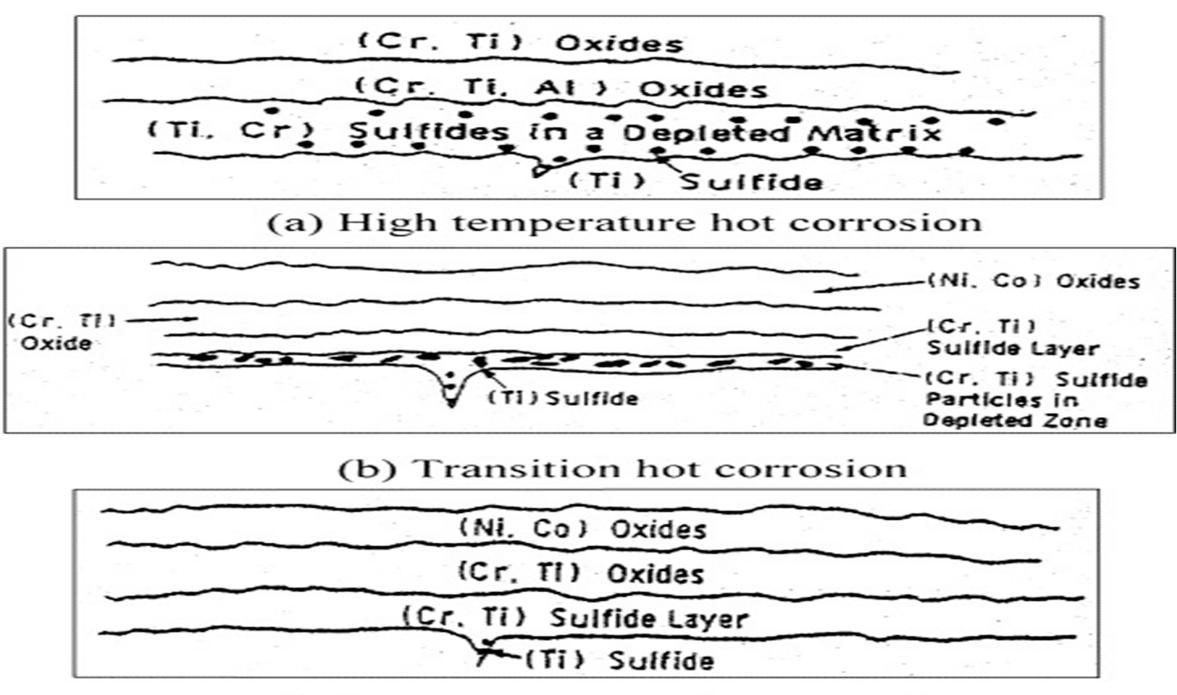
(c) Low temperature hot corrosion

Figure 2. Hot corrosion mechanism in a gas turbine blade. Reprinted with permission from ^[42]. 2004, M.R Khajavi, M. H Shariat.

In the case of gas turbines, the temperature can reach 1500 °C. Typically, the material used for coating is made of YSZ, which is stable up to 1200 °C. Above this temperature, the coating starts to damage. Due to this, the turbine's lifetime is decreased at high temperatures. The corrosion of superalloys or materials in the presence of oxidizing gas due to molten salt at a high temperature of 700–925 °C is called hot corrosion. The oxidation rate is fast at this temperature when alloys and metals are contaminated with salts. As a result, the protective oxide layer breaks down, and salts reach the metal surface, causing degradation ^[36]. Due to this degradation, the bond coat and topcoat are affected because of the porosity of the APS method in YSZ coating. Through pores and cracks, the molten salt penetrates the YSZ and reacts with a bond coat. ^[37] It is different from corrosion at low temperatures. Suppose the hot corrosion occurs at a temperature equal to the melting point of salt layers. In that case, it is hot corrosion of type 1, and the corrosion occurring at a temperature less than the melting point of the salt layers is called type 2 hot corrosion. The temperature range for high-temperature corrosion is 800 to 900 °C, and for low temperatures, it is 700 to 800 °C. **Figure 2** represents the hot corrosion mechanism at low and high temperatures of a substrate.

On the other hand, molten deposits are also responsible for the hot corrosion of thermal barrier coatings. The first mode of corrosion by molten deposits is chemical reaction attack by-products—for example, vanadium and sulfur. These products react with ceramic oxides to form corrosive melts. The second mode is mineralization due to the phase reaction of nonreactive liquid, which moves the nonequilibrium phase to the equilibrium phase. The third mode is the corrosion of the bond coat, in which corrodent melts or corrosive gases can enter the zirconia layer under some conditions and corrode the bond coat, eventually leading to the failure of TBC. The fourth mode is the physical damage of coating by the penetration of molten salt through the grains of TBC ^[40]. So, there is a need to keep the hot segment parts away from molten salt particles at high temperatures. A potentiodynamic polarization test in the saline solution measures the corrosion resistance. The current density for corrosion is between the range of 10^{-5} to 10^{-6} A/cm² ^[41]. If the turbine blade is not coated, then pitting and corrosion can affect the blade, and the consequences may be severe if there is a salty environment.
