Grouting in Coal Mass

Pre-grouting as an effective means for improving the stability of roadways can reduce maintenance costs and maintain safety in complex mining conditions. In the Guobei coal mine in China, a cement pre-grouting technique was adopted to enhance the overall strength of soft coal mass and provide sufficient support for the roadway. However, there are very limited studies about the effect of grouting on the overall strength of coal in the laboratory.

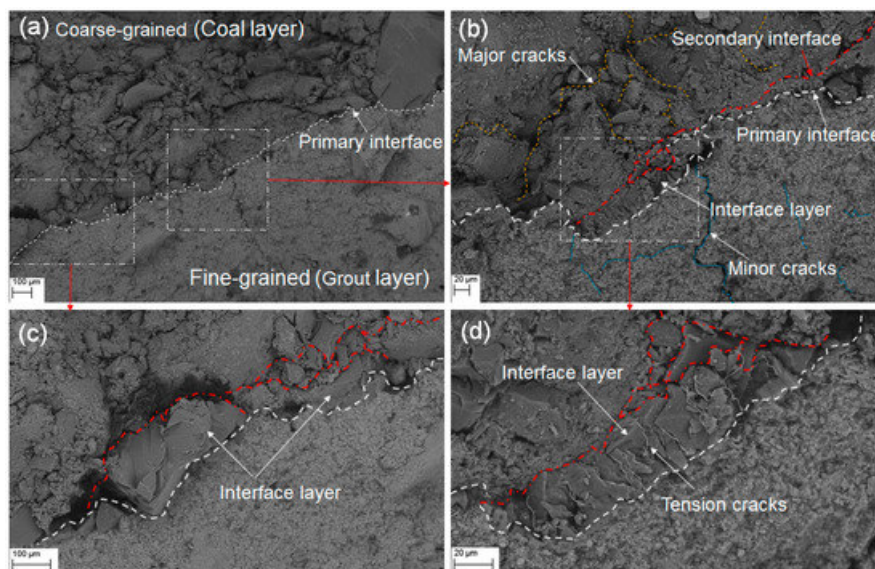
Figure 2. The microscope interface properties of the coal-grout structure. **(a)** A general view of the primary interface separated by the top coarse-grained coal layer and the bottom fine-grained grout layer. **(b)** A close-up of a photomicrograph showing three main parts of the coal-grout interface (primary interface, secondary interface and interface layer). **(c)** A typical interface layer with intact coal grains or coal matrix. **(d)** Another typical interface layer with cracked coal grains by micro-tension.

The overall shear strength and stiffness of grouted coal is affected by the interface between coal and grout. Analyzing the microscopic interfacial structure is helpful to reveal the failure mechanism of the specimen. The scanning electron microscopic (SEM) image on the surface of grouted coal is shown in **Figure 2**. As illustrated in **Figure 2a**, there was a primary interface between the coarse-grained coal layer and the fine-grained grout layer. The primary interface was not completely surface contact, but instead comprised irregular point contacts that could result in a relatively weak and discontinuous bonding force. Furthermore, microscopic observations indicated that there was an intermittent secondary interface near the coal layer (**Figure 2b**). It contained one or more interface branches. Between the primary interface and secondary interface, the intermediate layer like a "transition zone" was generated (shown in **Figure 2b-d**). Besides, the two mediums considerably differed from each other in microcracks. As shown in **Figure 2b**, many major cracks were in the coal layer between coal particles and coal matrix, compared with a few minor cracks in the grout layer. This indirectly verified the reason why grout has higher strength and stiffness when it suffers shearing.

From **Figure 2c,d**, two typical statuses of the interface layer were revealed. One is a relatively complete layer consisting of the large coal grains and coal matrix (**Figure 2c**). Another is a cracked layer subjected to the tension that resulted in many tiny cracks in the coal matrix (**Figure 2d**). The secondary interface could be viewed as a series of coal failures near the primary interface, which formed after the primary interface. The bonding force between the coal layer and grout layer was created when cement grout solidified. Furthermore, micro shrinkage of cement would occur during this curing process, leading to micro-tension between grout and coal. When the micro-tension exceeded the ultimate tensile stress in coal or the cohesive strength between coal grains and coal matrixes, the different failure patterns in the interface layer would engender. The interface layer of grouted coal observed in this study is different from the interfacial transition zone (ITZ) investigated by [29][30]. ITZ is the interface between cement pastes and aggregates, which has a higher porosity and fills with the deposition of hydration products [31][32]. The “coal-grout interface layer” can be seen as an intermediate layer filled with crushed coal between the grout layer and a relatively stable coal layer. When the coal-grout structure suffered high stress, the irregularly cracked interface layer failed easily, which induced the stress drop and affected the overall stability of grouted coal.

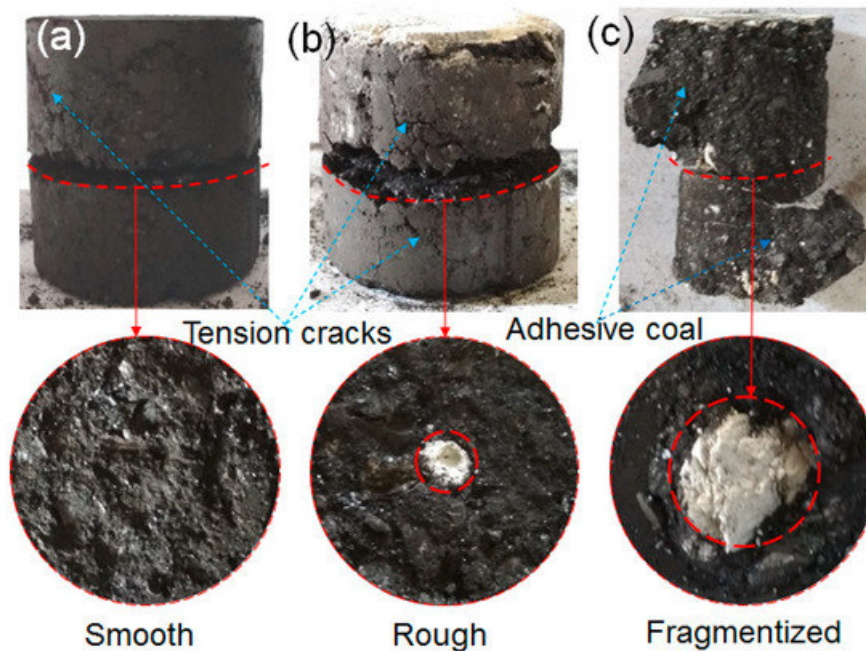
Figure 3. The comparison of typical failure patterns and shear planes for specimens after shear tests. (a) Coal failure, type I. (b) Coal and grout composite failure, type II. (c) Coal failure before grout failure (multi-stage failure), type III.

The failure process of a rock or coal sample can be seen as a successive evolution of cracks at the mesoscopic level [33][34]. As for the coal and grouted coal, the appearance, propagation, and coalescence of mesoscopic cracks resulted in their failure, when they suffered shearing. **Figure 3** shows images of typical failure patterns of the specimen after shear tests. As described above, there were three typical failure modes for coal and grouted coal. In **Figure 3a**, it illustrates a smooth shear plane in pure coal sample, corresponding to the failure type I. The composite failure type II for the grouted coal is depicted in **Figure 3b**. A relatively rough shear plane was formed. Tension cracks can be found on the surface from both **Figure 3a,b**. Based on the shear stress-displacement curves for failure I and II, a gentle process by the development and coalescence of cracks in coal and grout can be deduced during the shearing. When grout percentage and/or normal stress increased, the failure of the specimen is shown in **Figure 3c**, which corresponds to the failure type III. The coal around the solidified grout was fragmented. A small part of coal stuck on the surface. The “coal-grout interface layer” described above became weak and crushed when it suffered high stress. In this case, the combination of coal and grout was no longer stable. Hence, the cracks in external coal coalesced and failed, then the fragmented interface layer induced a stress drop followed by the propagation and coalescence of cracks in the grout. It is characterized by multi-stage failure (or non-simultaneous failure).
